STAR ONLINE PUBLICATION

Case Number: S2303000001

Release Date: January 2023

Symptom/Vehicle Issue: Moaning, Grinding, or Groaning Type Noise From The Driveline Between 50-70 MPH (80-112 kph).

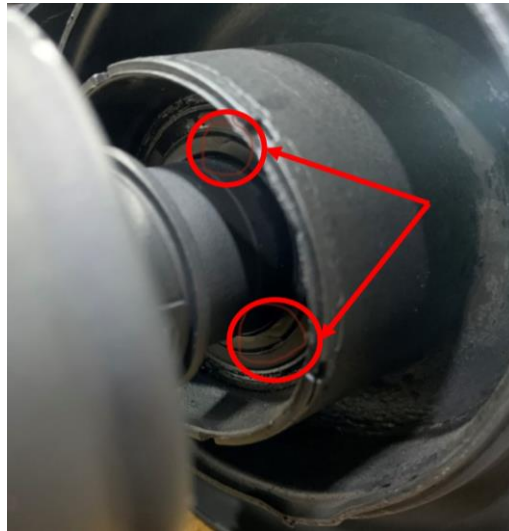
Figure 1

6. Inspect the rear driveshaft center bearing for signs of damage. Please see (Figure 1) for the area to inspect. Were there any visible issues with the center bearing found?
 - a. Yes>>> Replace the rear driveshaft. For detailed repair procedures, please refer to Service Library Service Information Section 03 – Differential and Driveline > Shafts, Axle/Drive/Half > Removal and Installation > Rear Driveshaft.
 - b. No>>> This document no longer applies. Please refer to normal published diagnostics for the concern and repair as necessary.
