STAR ONLINE PUBLICATION

Case Number: S2308000009

Symptom/Vehicle Issue: Electric Power Steering (EPS) Will Not Calibrate, Negative Response Error Code 0X10

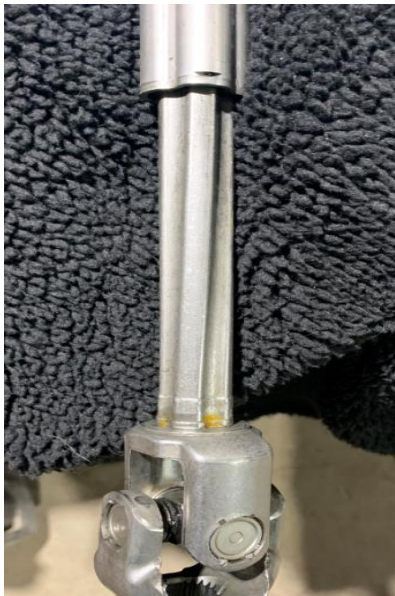
Performing a steering wheel lock to lock verification from center can help identify potential differences from side to side which can aid in locating potential calibration failures. Below is an example of a twisted intermediate shaft (after an accident) inhibiting EPS relearn which is used when the EPS is replaced, or the front suspension has been realigned.

Discussion: Verify the steering gear has been installed correctly by keeping steering wheel as straight as possible and checking front wheel orientation (they should be as straight as possible) offsets greater than +/- 7.5 degrees can inhibit EPS learn. Some conditions identified in the past when calibrating have been incorrectly installing EPS gear to intermediate input shaft connections or possibly a bent component.
