NUMBER: 08-006-23

GROUP: 08 - Electrical

6.7L Cummins No Start

This bulletin involves replacing the starter nut with the more conductive nut.

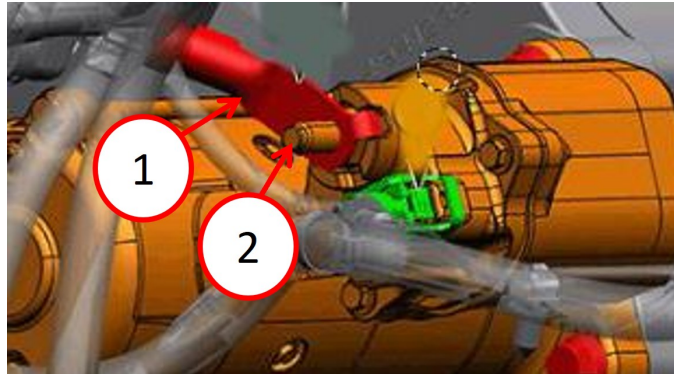
Fig. 1
B+ Cable And Starter Stud

NOTE: This symptom/condition is caused from a poor connection to the starter.

1. Disconnect and isolate both the negative and positive battery cable(s). Refer to the detailed service procedures available in DealerCONNECT/Service Library under: Service Info>08 - Electrical / 8F - Engine Systems / Battery System / Standard Procedure.
2. Raise and support vehicle. Refer to the detailed service procedures available in DealerCONNECT/Service Library under: Service Info>04 - Vehicle Quick Reference / Hoisting / Standard Procedure.
3. Remove the B+ cable nut and the B+ cable from the starter stud (Fig. 1) . **Discard the nut.**

4. Using the new B+ cable nut, install the B+ cable on the starter stud (Fig. 1) . Tighten the B+ cable nut to 18 N·m (13 ft. lbs.).
5. Lower the vehicle.
6. Connect the positive and negative battery cable(s). Refer to the detailed service procedures available in DealerCONNECT/Service Library under: Service Info>08 - Electrical / 8F - Engine Systems / Battery System / Standard Procedure.
