REFERENCE:	TSB: 23-004-23 GROUP 23 - Body	Date:	January 7, 2023	REVISION:	-
VEHICLES AFFECTED:	2022 (MV) Jeep Compass This bulletin applies to vehicles built on or after October 22, 2022 (MDH 1022XX) and on or before October 29, 2022 (MDH 1029XX) equipped with Full Sunroof, Power Front, Fixed Rear (Sales Code GWJ).			MARKET APPLICABILITY:	
				<input type="checkbox"/> NA	<input type="checkbox"/> CH
				<input checked="" type="checkbox"/> EE	<input type="checkbox"/> IAP
				<input checked="" type="checkbox"/> SA	<input checked="" type="checkbox"/> MEA
CUSTOMER SYMPTOM:	Customers may comment on the following: <ul style="list-style-type: none"> Audible sound coming from the rear sunroof area over rough roads. 				
CAUSE:	Missing adhesive between interior roof frame panels.

This bulletin involves inspecting for noise and possibly sealing the gap between the rear roof frame panels.

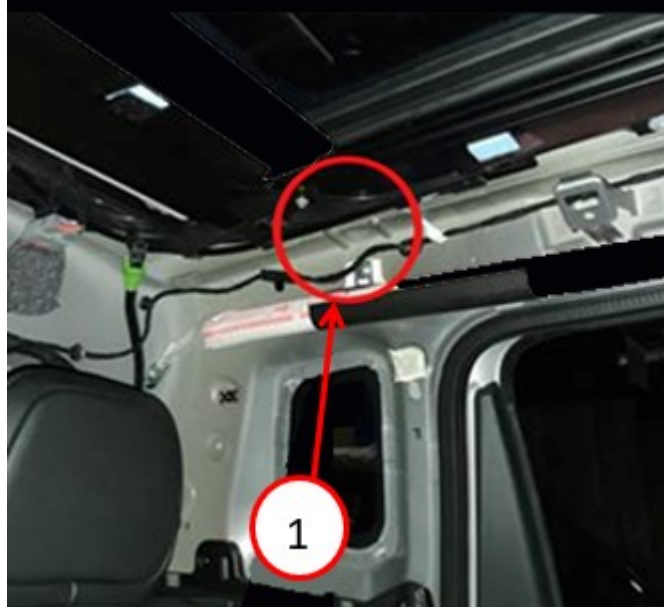
Fig. 1
Sealing Area

1- Roof Panel Sealing Area

1. Remove the headliner. Refer to the detailed service procedures available in DealerCONNECT> Service Library under: Service Info>23 - Body / Interior / Headliner / Removal.
2. Locate the area above the C pillar window that needs sealing ([Fig. 1](#)) .
