<b>REFERENCE:</b>	<b>TSB:</b> 08-008-23 <b>GROUP</b> 08 - Electrical	<b>Date:</b>	January 12, 2023	<b>REVISION:</b>	08-117-21, 08-102-21 and 08-016-19 REV. F
<b>VEHICLES AFFECTED:</b>	<p>2018 - 2022 (LA) Dodge Challenger                  2018 - 2022 (LD) Dodge Charger                  2018 - 2022 (LX) Chrysler 300                  2018 - 2021 (DS) RAM 1500 Pickup                  2018 (DJ) RAM 2500 Pickup                  2018 (D2) RAM 3500 Pickup                  2018 (DD) RAM 3500 Cab Chassis                  2018 (DF) RAM 3500 &lt;10K Cab Chassis                  2018 (DP) RAM 4500/5500 Cab Chassis</p> <p><b>NOTE:</b>This bulletin applies to vehicles equipped with a Uconnect 4C With 8.4" Display radio (Sales Codes UAS or UCS).</p>			<b>MARKET APPLICABILITY:</b>	
<b>CUSTOMER SYMPTOM:</b>	<p><b>Customers may experience one or more of the following:</b></p> <ul style="list-style-type: none"> <li>• **Wi-Fi hotspot connection failure.</li> <li>• Speaker popping, crackle noise during Voice Recognition (VR) response and navigation guidance.</li> <li>• Mobile Station Integrated Services Digital Network (MSISDN) missing from radio, no connected services working.**</li> <li>• Wireless con

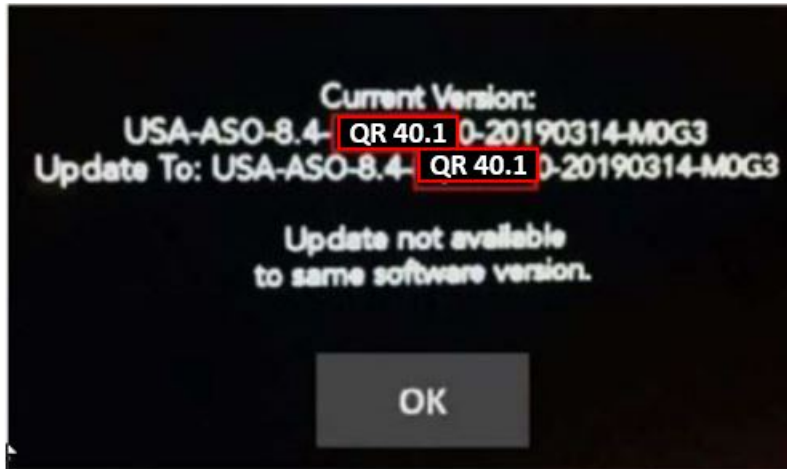
Fig. 5

Screen Displayed When Radio Software Level Is Up To Date

11. If the radio software is already up to date, the screen in (Fig. 5) will be displayed. Press “OK” and remove the USB flash drive.

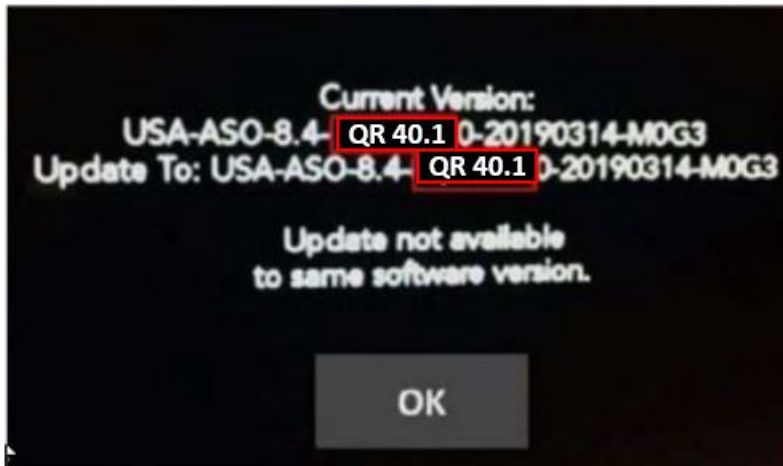
Fig. 9

**Radio Software Has Been Updated**

15. After the update has completed, the radio will shut down. With the USB flash drive still inserted in the USB port, cycle the ignition back to the run position. If the radio software was updated correctly the “Current Version:” and the “Update To:” software levels in (Fig. 9) will display the identical software level. Press “OK” and remove the USB flash drive.
