REFERENCE:	TSB: 08-010-23 GROUP 08 - Electrical	Date:	January 14, 2023	REVISION:	08-035-19 REV. A
VEHICLES AFFECTED:	2018 (RU) Chrysler Pacifica NOTE: This bulletin applies to vehicles equipped with an Uconnect 4NAV With 8.4" Display (Sales Codes UJV, UGV, UDV or UKV) with 760 Watt Amplifier (Sales Code RDH) or 506 Watt Amplifier (Sales Code RFD).			MARKET APPLICABILITY: <input type="checkbox"/> NA <input checked="" type="checkbox"/> IPA <input checked="" type="checkbox"/> EE <input checked="" type="checkbox"/> MEA <input checked="" type="checkbox"/> SA <input checked="" type="checkbox"/> CH	
CUSTOMER SYMPTOM:	Customers may experience one or more of the following: <ul style="list-style-type: none"> • Arabic language missing (UJV only). • Russian language missing (UGV only). • PHEV vehicles may intermittently not charge when using the scheduled charging feature instead of "Charge Now" button. • When shifting to reverse, the radio displays blue/black lines instead of the rear view camera and is followed by a reset. • Radio stays on with key "OFF" and drains battery. • Wi-Fi feature cannot be renewed after the trial period has expired. • Radio reboots multiple times when a Samsung J-7

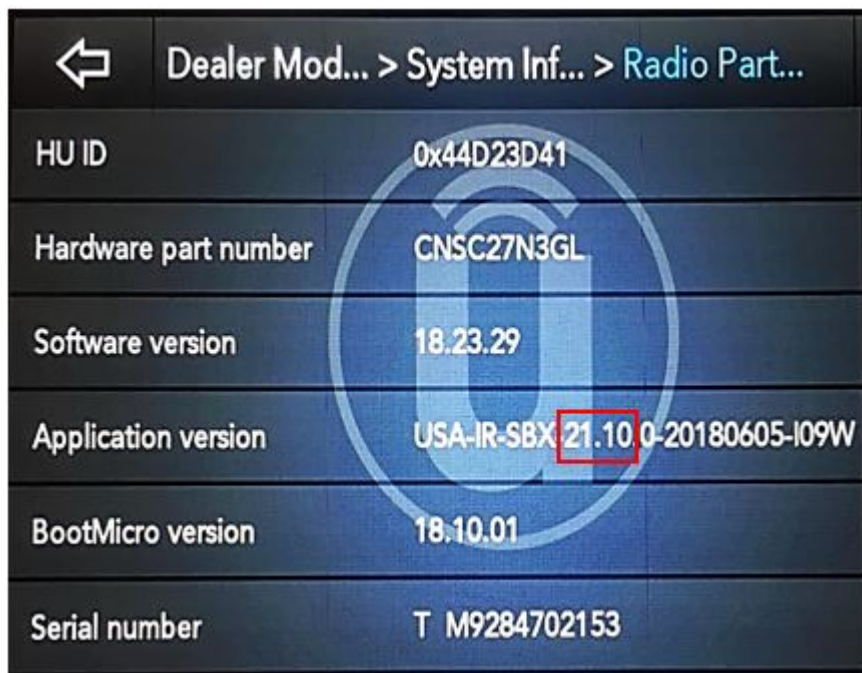
Fig. 1
Radio Software Level Screen

1. Verify the radio software version. Radio must be in Dealer Mode to verify. To put the radio in Dealer Mode, follow these steps:
 - a. Press and hold both lower corners of the display screen, until the Dealer Mode screen appears (approximately seven seconds). Release buttons.
 - b. Select "Radio Part Information". The software level will be listed next to "Application Version".
2. Is the radio software level ("Application Version") currently at or higher than (Fig. 1) ?
 - UJV, or UGV - 21.9
 - UDV or UKV - 19.11
 - YES >>> The radio software is already up to date. This bulletin has been completed. Normal diagnostic need .
 - NO >>> The radio software needs to be updated. Back out of Dealer Mode and proceed to [Step 1](#) of the Repair Procedure.

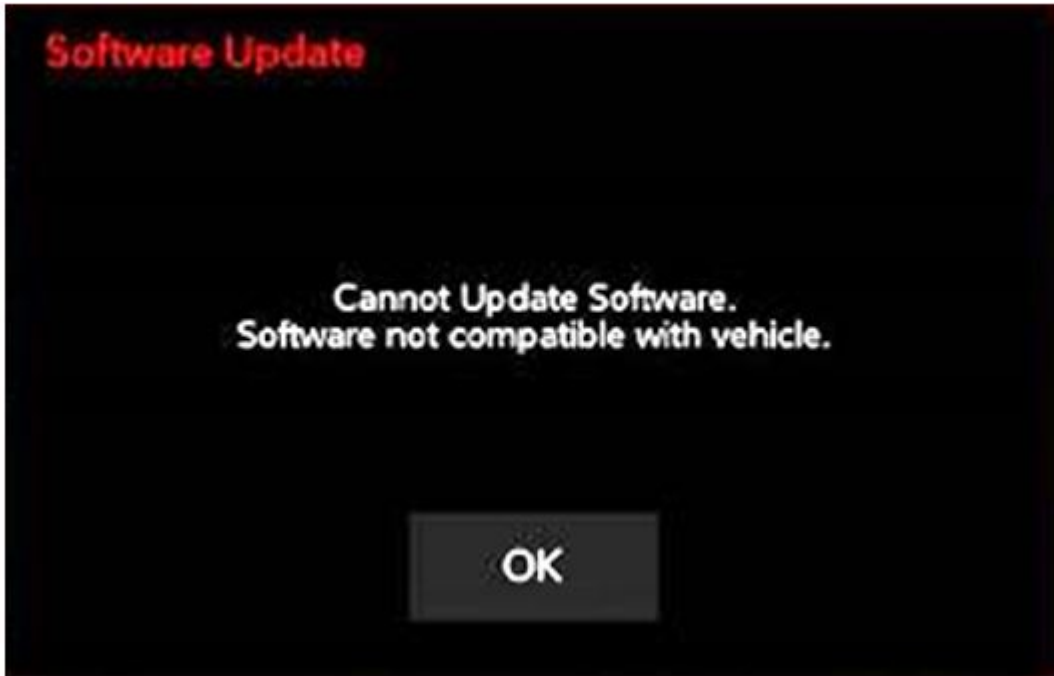
Fig. 6
Software Not Compatible

11. If the screen in (Fig. 6) is displayed, the USB flash drive was not set up correctly. Use a top name brand USB flash drive and create a new flash drive and start the update again.
