Technical Service Bulletin (TSB)
UAR and UCR Radio Enhancements

REFERENCE:	TSB: 08-009-23 GROUP 08 - Electrical	Date:	January 14, 2023	REVISION:	08-035-19 REV. A
VEHICLES AFFECTED:	2018 - 2020 (RU) Chrysler Pacifica NOTE: This bulletin applies to vehicles equipped with a Uconnect 4 With 8.4" Display (Sales Codes UAR or UCR).			MARKET APPLICABILITY: <input checked="" type="checkbox"/> NA <input type="checkbox"/> IAP <input type="checkbox"/> EE <input type="checkbox"/> MEA <input type="checkbox"/> SA <input type="checkbox"/> CH	
CUSTOMER SYMPTOM:	<p>Customers may experience one or more of the following:</p> <ul style="list-style-type: none"> • **Wi-Fi hotspot connection failure. • Speaker popping, crackle noise during Voice Recognition (VR) response. • Mobile Station Integrated Services Digital Network (MSISDN) missing from radio, no connected services working.** • Lost radio presets. • High pitch chime noise. • Contact list not loading. • Remote app inoperative. • High pitch squeal, pop or humming sound coming from all of the speakers. • Backup camera gridlines missing. • Radios resets when a wireless connectivity paired phone receives two text messages one after another simultaneo

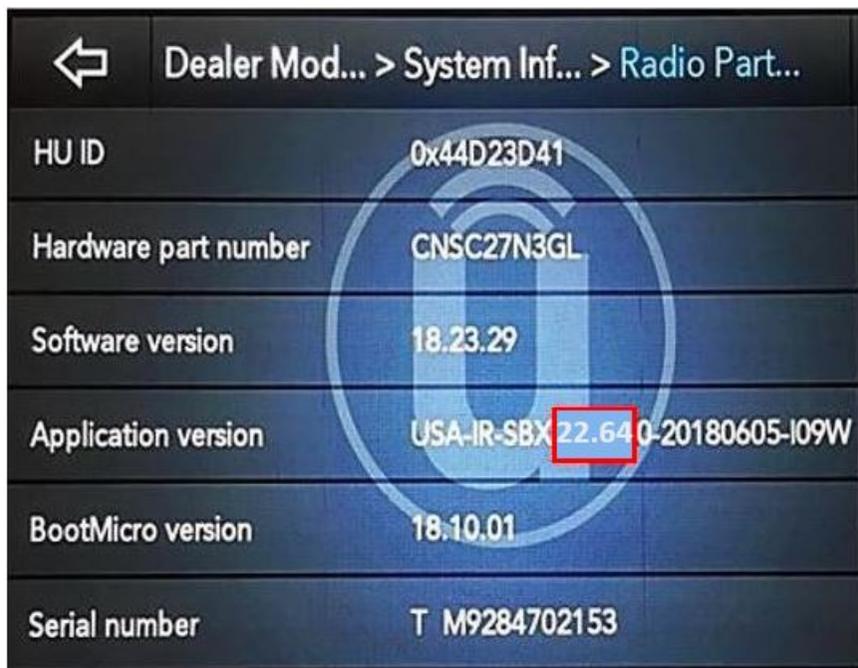
**Fig. 1
Radio Software Level Screen**

1. Verify the radio software version. Radio must be in Dealer Mode to verify by following these steps:
 - a. Press and hold both lower corners of the display screen, until the Dealer Mode screen appears (approximately seven seconds). Release screen.
 - b. Select "Radio Part Information". The software version will be listed next to "Application Version" (Fig. 1) .

2. What is the radio software level (Application Version) at?
 - **40.1 or higher >>> The radio software is already up to date. Normal diagnostics should be performed.
 - At or above 22.64 and under 40.1 >>> The radio will only need one USB update. Proceed to [Step 1](#) of the Repair Procedure.

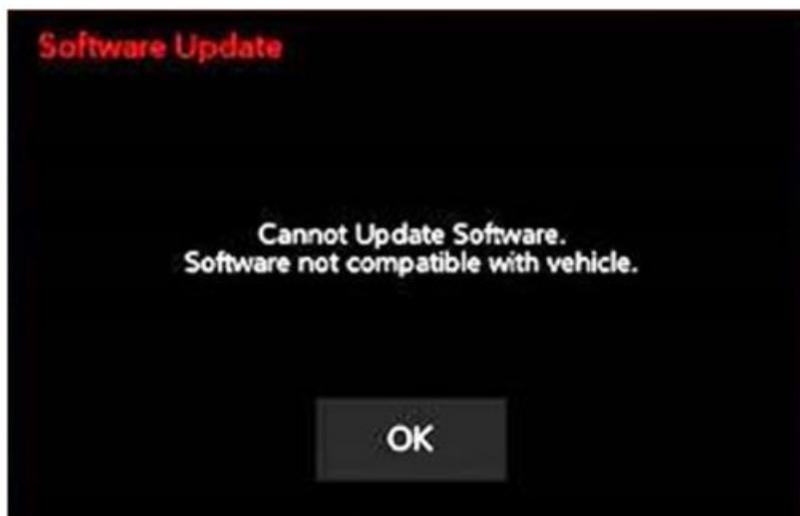
Fig. 4
Software Not Compatible Screen

- If the screen in (Fig. 4) is displayed, the USB flash drive was not set up correctly. Use a top name brand USB flash drive, like Kingston, create a new USB flash drive and start the update again.

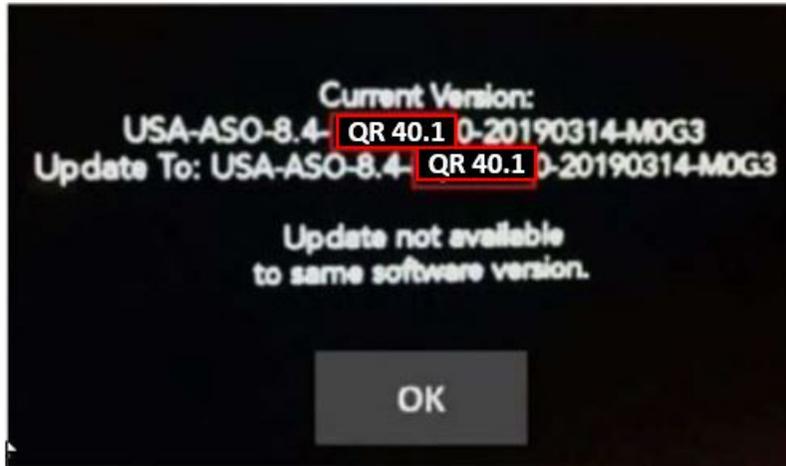
Fig. 5

11. If the radio software is already up to date, the screen in (Fig. 5) will be displayed. Press “OK” and remove the USB flash drive.

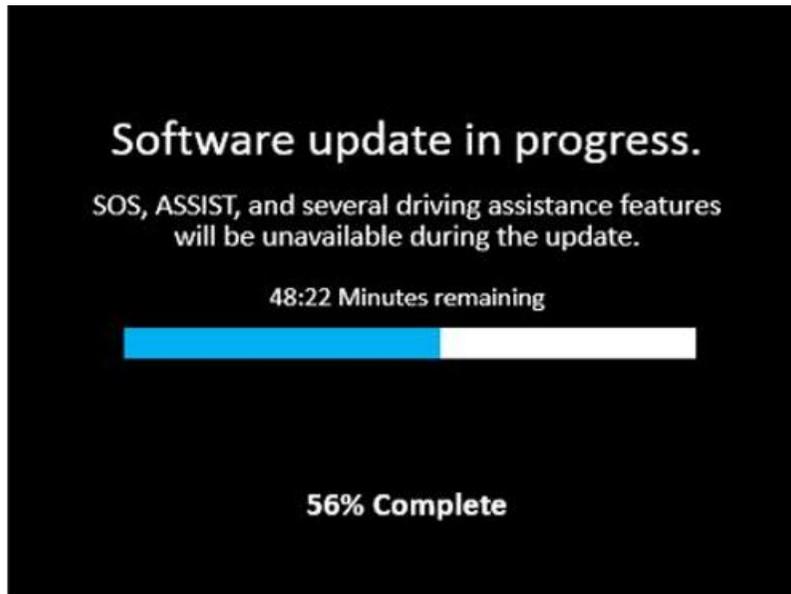
Fig. 8
Software Update In Progress

14. The radio will reboot and the update will begin. The update should only take 25 minutes, the timer on the screen may display the incorrect time remaining (Fig. 8) .

NOTE: The completion indicator may not reach 100%, even though the software update has been completed. Once the software update has finished, the radio and display screen will turn off.
