REFERENCE:	TSB: 23-006-23 GROUP 23 - Body	Date:	January 20, 2023	REVISION:	-
VEHICLES AFFECTED:	2022 (WD) Dodge Durango This bulletin applies to vehicles built on or after May 12, 2022 (MDH 0512XX) and on or before June 30, 2022 (MDH 0630XX).			MARKET APPLICABILITY:	
				<input checked="" type="checkbox"/> NA	<input type="checkbox"/> CH
				<input checked="" type="checkbox"/> EE	<input type="checkbox"/> IAP
				<input checked="" type="checkbox"/> SA	<input checked="" type="checkbox"/> MEA
CUSTOMER SYMPTOM:	Customers may comment on one or more of the following: <ul style="list-style-type: none"> One or both A-Pillar trim is warped and/or not seated. A-Pillar trim squeaks or rattles. 				
CAUSE:	Trim fasteners not seated.

This bulletin involves inspecting and possibly replacing one or both A-Pillar trims.

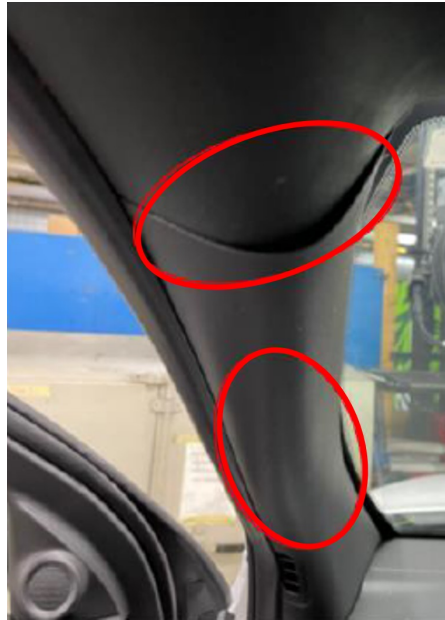
Fig. 1

1. Visually inspect both A-Pillar trims to ensure they are fully seated and/or not warped (Fig. 1) .

A-Pillar Trim Not Fully Seated And/Or Warped

NOTE: Attempted re-seating of the A-Pillar will not correct this condition.

2. Were one or both A-Pillar trims not fully seated and/or warped (Fig. 1) ?
 - YES>>>Proceed to [Step 1](#) of the Repair Procedure.
 - NO>>> This bulletin has been completed, use inspect LOP (23-20-16-95) to close the active RSU.

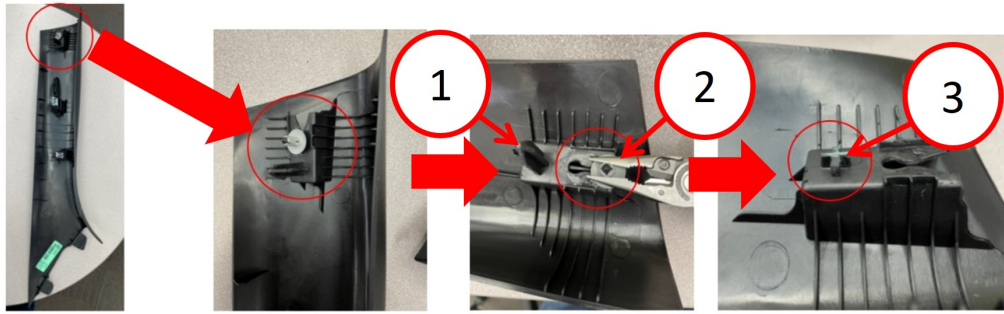
Fig. 2
Gray Pin And 4-Way Locator

- 1 - 4-Way Locator
- 2 - Gray Pin
- 3 - Removed 4-Way Locator

- Using the new A-Pillar trim and a suitable pliers tool, remove gray pin from the A-Pillar trim by pulling pin out of trim groove (Fig. 2) .

- Using a suitable cutting tool, cut away as much of the 4-way locator pin as possible (Fig. 2) .
- Install the new/modified A-Pillar trim. Refer to the detailed service procedures available in DealerCONNECT> Service Library under: Service Info> 23 - Body / Interior / Panel, A-Pillar Trim / Installation.
