<b>REFERENCE:</b>	<b>TSB:</b> 23-007-23 <b>GROUP</b> 23 - Body	<b>Date:</b>	January 20, 2023	<b>REVISION:</b>	23-050-22
<b>VEHICLES AFFECTED:</b>	<b>2022 (MV) Jeep Compass</b> This bulletin applies to vehicles built on or after <b>September 20, 2022 (MDH0920XX)</b> and on and before <b>**September 24, 2022 (MDH0924XX)**</b> .			<b>MARKET APPLICABILITY:</b>	
				<input type="checkbox"/> NA <input type="checkbox"/> SA <input checked="" type="checkbox"/> EE	<input checked="" type="checkbox"/> MEA <input type="checkbox"/> IAP <input type="checkbox"/> CH
<b>CUSTOMER SYMPTOM:</b>	<b>Customers may comment on the following:</b> <ul style="list-style-type: none"> <li>The center grille section is unfinished (smooth / not grained) (Fig. 1) .</li> </ul>				
<b>CAUSE:</b>	Incorrect front center grille

This bulletin involves replacing the center grille.

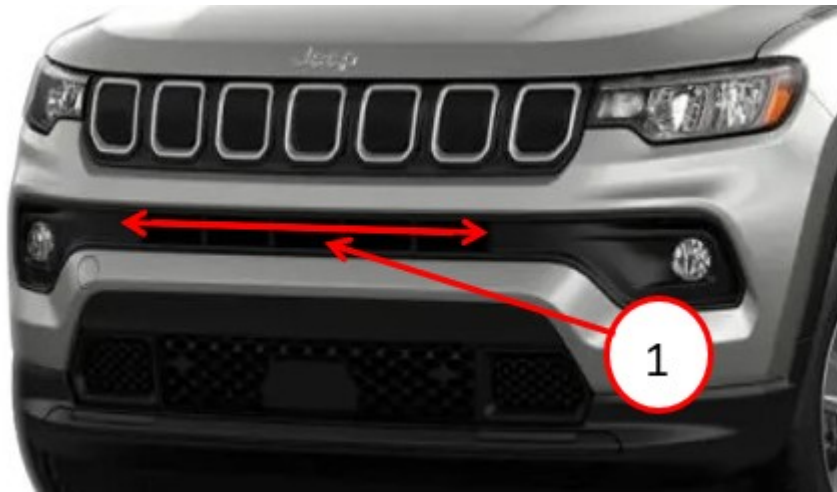
**Fig. 1**  
**Center Grille Section**

- The center grille section is unfinished (smooth / not grained) (Fig. 1) .

1 - Center Grille Section

1. Replace the center grille. Refer to the detailed service procedures available in DealerCONNECT/Service Library under: Service Info>23 - Body / Exterior / Grille / Removal and Installation/Removal - Center.

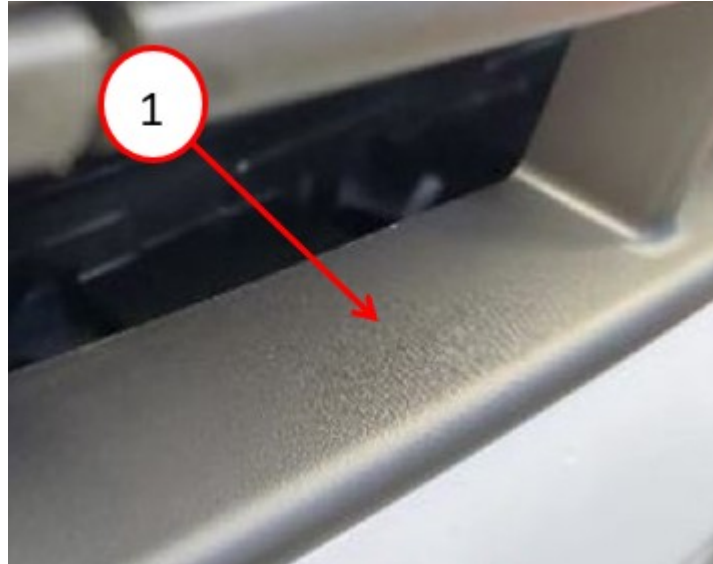
**Fig. 2**  
**Correct Center Grille With Grained Surface**

- The correct center grille surface is supposed to be grained: (Fig. 2) .

1 - Grained Surface

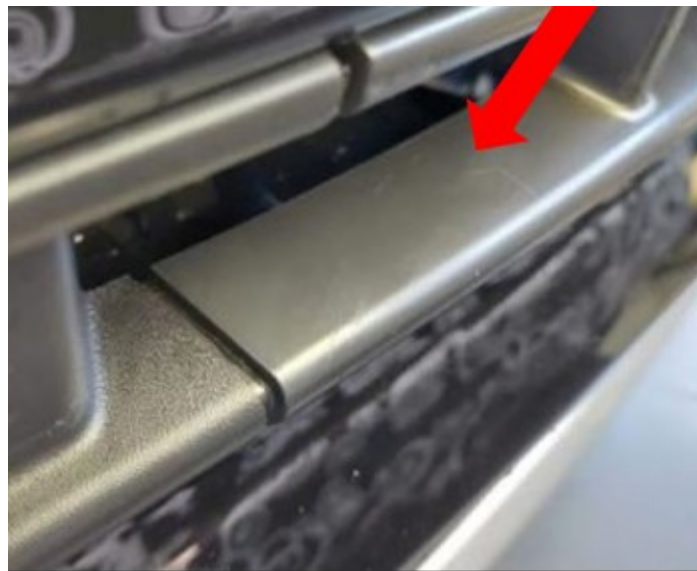
**Fig. 3**  
**Incorrect Center Grille With Smooth Surface**

- If the center grille surface is smooth, vehicle has the incorrect center grille: (Fig. 3) .

1. Is the center grille section smooth?
  - YES>>> Proceed to [Step 1](#) of the repair procedure.
  - NO>>> This bulletin has been completed, use inspect LOP (23-02-01-9B) to close the active RSU.
