NUMBER: 19-002-23

Outer Tie Rod Ball And Socket Noise

2022 (MV) Jeep Compass (Italy/PHEV)

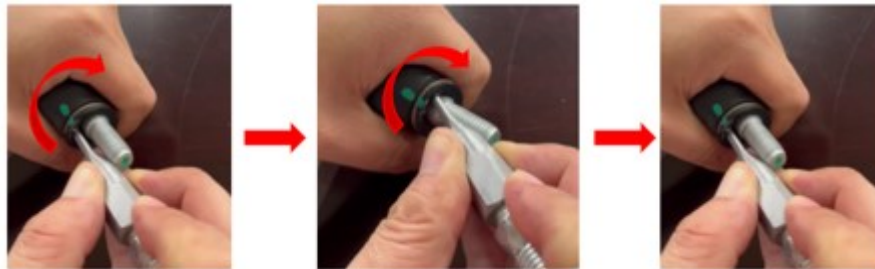
- Outer tie rod ball and socket noise.

NOTE: Noise noticed during steering wheel rotation after vehicle mileage between 1,000 km (621 miles) and 3,000 km (1,864 miles) and when the tie rods achieve a temperature greater than 60 °C (140 °F).

Fig. 1
Greasing Ball Joint

5. Using a suitable needle greasing tool loaded with 5 ml of grease, grease the tie rod outer ball joint (Fig. 1) .
