NUMBER: 08-016-23

Updated Front Turn Signal or Park Lamp Bulb

2014 - 2020

Dodge Durango

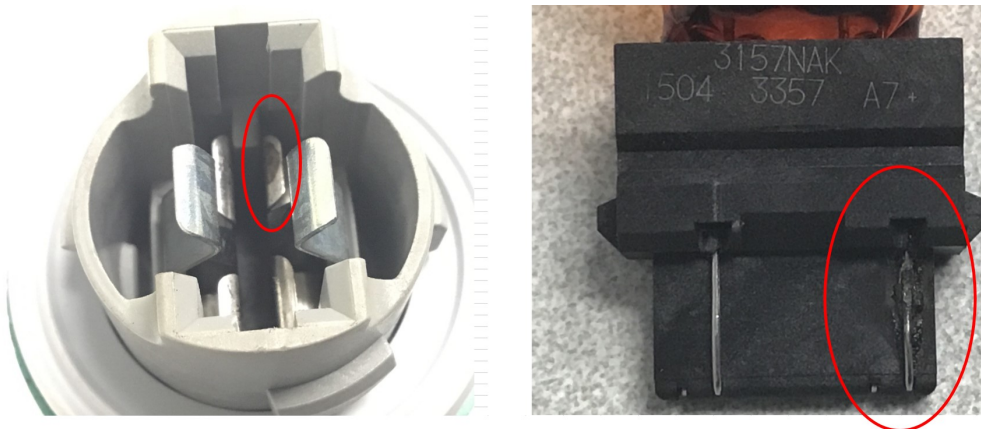
Fig. 1

If arcing across the electrical socket or a burn contact on the bulb is found, the socket and bulb (Fig. 1) must be replaced with updated current parts.

Arcing Socket and Burned Connection on the Bulb

The updated electrical socket (Mopar # 68333194AB) must be used when doing repair. Any bulb being replaced must be replaced with the following Mopar parts supersessions depending on where the bulb is located on the front of the vehicle:

- Mopar # L00003157A
- Mopar # L0003157AK
- Mopar # L0003757AK
- Mopar # L0007444NA
