REFERENCE:	TSB: 08-017-23 GROUP 08 - Electrical	Date:	January 24, 2023	REVISION:	-
VEHICLES AFFECTED:	2022 - 2023 (WL) Jeep Grand Cherokee 2022 - 2023 (WS) Grand Wagoneer/Wagoneer NOTE: This bulletin applies to vehicles built on or after September 12, 2022 (MDH 0912XX) and on or before October 14, 2022 (MDH 1014XX) equipped with: <ul style="list-style-type: none"> • Uconnect 5 W 8.4" Display and Uconnect 5 W NAV 8.4" Display (Sales Codes UBF, UEF, UBL and UEL). • Uconnect 5 W NAV 10.1" Display (Sales Codes UBN and UEN). • Uconnect 5 W NAV 12.0" Display (Sales Codes UBQ and UEQ). 			MARKET APPLICABILITY: <input checked="" type="checkbox"/> NA <input type="checkbox"/> MEA <input type="checkbox"/> SA <input type="checkbox"/> IAP <input type="checkbox"/> EE <input type="checkbox"/> CH	
CUSTOMER SYMPTOM:	<ul style="list-style-type: none"> • Battery drain after hooking up WiTech. • Black display screen comes on during start up. (Rearview camera functions normally).

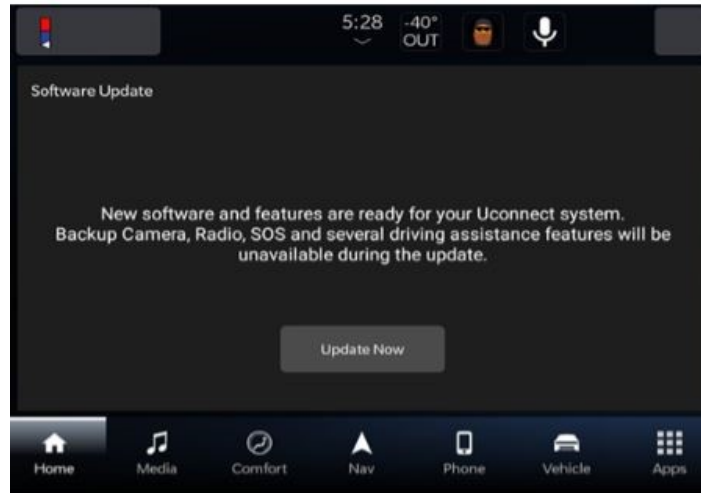
Fig. 1
Software Acceptance Screen

Customers will see a notification on their radio screen when new software is available for their radio (Fig. 1). The owner will have the option to update the radio or schedule the update for later. There is not an option to decline the update indefinitely, the update must be performed.

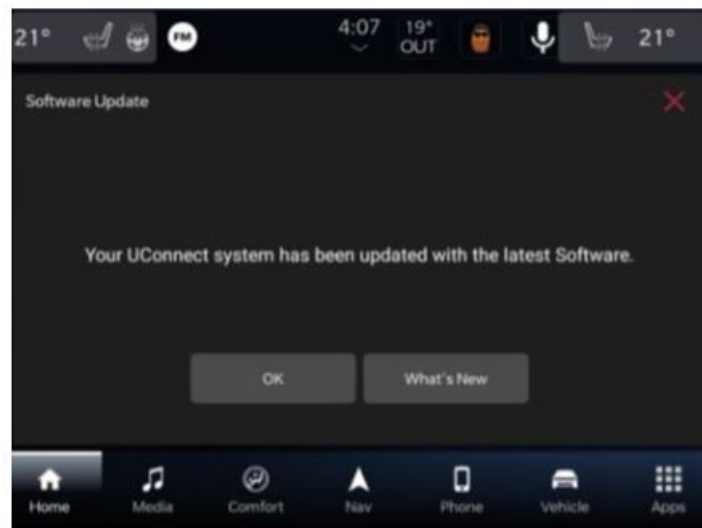
Fig. 2
Software Update Confirmation Screen

3. Upon completion of update, the radio will display a confirmation message (Fig. 2).
