Technical Service Bulletin (TSB)
Interior Rear Facing Camera Bezel is Loose and or Falls Out of Headliner

REFERENCE:	TSB: 23-010-23 GROUP 23 - Body	Date:	January 24, 2023	REVISION:	-
VEHICLES AFFECTED:	2021 - 2023 (WL) Jeep Grand Cherokee NOTE: This bulletin applies to vehicles built on or before October 10, 2022 (MDH 1010XX) equipped with an Interior Rear Facing Camera (Sales Code XPR).			MARKET APPLICABILITY:	
				<input checked="" type="checkbox"/> NA	<input type="checkbox"/> CH
				<input checked="" type="checkbox"/> EE	<input checked="" type="checkbox"/> IAP
				<input checked="" type="checkbox"/> SA	<input checked="" type="checkbox"/> MEA
CUSTOMER SYMPTOM:	Customers may comment on the following:				
	<ul style="list-style-type: none"> The interior rear facing camera (FamCam) bezel, is loose and/or falls out of headliner (Fig. 1) . 				
CAUSE:	Low retention force caused by retention clips at low end of tolerance.

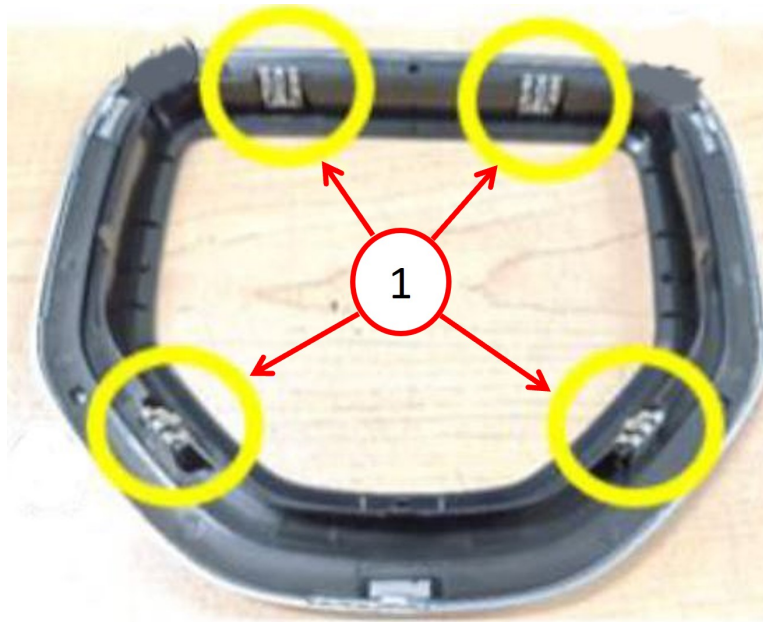
Fig. 2
Four Retention Clip Locations

1. Gently pull down on each corner of the interior rear facing camera bezel at all four retention clip locations (Fig. 2) .

1 - Retention Clips

2. Were one or more retention clips (Fig. 2) found to be loose?
 - YES>>> Proceed to [Step 1](#) of the Repair Procedure.
 - NO>>> This bulletin has been completed. Use inspect LOP (08-20-09-90) to close the active RSU.

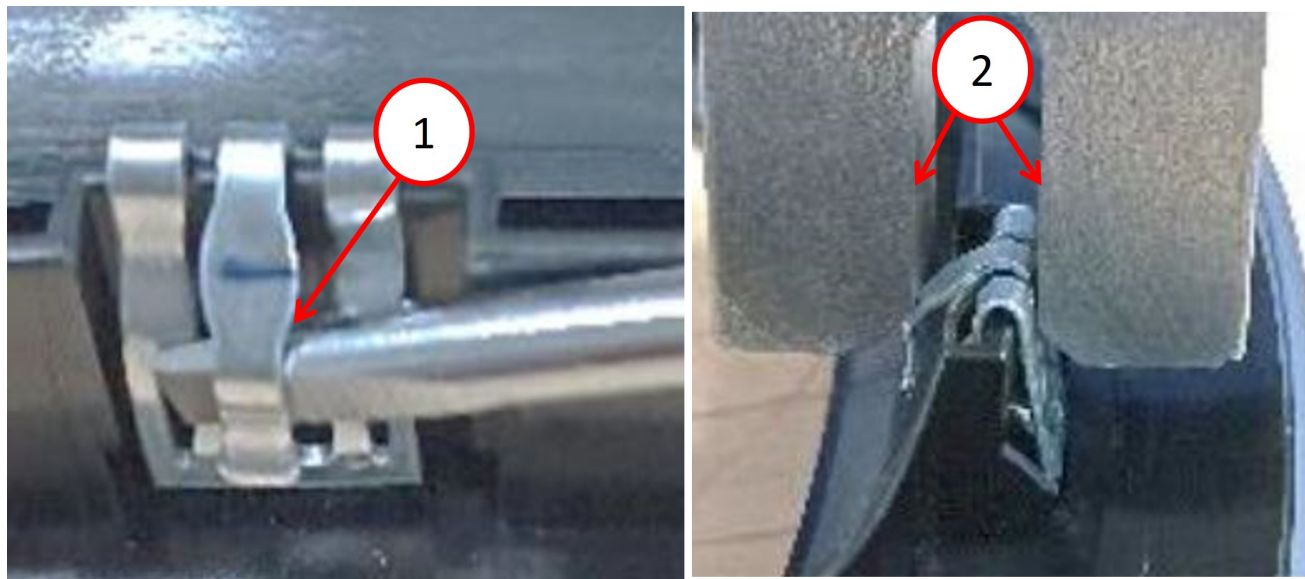
Fig. 3
Opening Retention Clip Nose And Gap

- 1 - Retention Clip
- 2 - 8 mm (0.31 in.) Clip Gap

1. Remove the interior rear facing camera bezel from the headliner (Fig. 1) by pulling down on each corner of the bezel.
2. Using a flat blade tool, gently open the nose of the retaining clip out to 8 mm (0.31 in.) (Fig. 3) . **Perform this step on each of the four retaining clip noses.**
