REFERENCE:	TSB: 23-008-23 GROUP 23 - Body	Date:	January 24, 2023	REVISION:	23-041-22
VEHICLES AFFECTED:	<p>2022 (JL) Jeep Wrangler 2022 (J6) Jeep Wrangler (CKD) This bulletin applies to vehicles built on or after August 01, 2021 (MDH 0801XX) and on or before **November 09, 2022 (MDH 1109XX)** equipped with:</p> <ul style="list-style-type: none"> LED Tail Lamp (Sales Code LAY) with E-Mark Exterior Lighting (Sales Code LP4) with or without Blind Spot Cross Path Detection (Sales Code XAN). 	MARKET APPLICABILITY:			
		<input type="checkbox"/> NA		<input type="checkbox"/> MEA	
		<input type="checkbox"/> SA		<input checked="" type="checkbox"/> IAP	
		<input checked="" type="checkbox"/> **EE**		<input checked="" type="checkbox"/> CH	
CUSTOMER SYMPTOM:	<p>The customer may experience the following:</p> <ul style="list-style-type: none"> Water in the left and/or right tail lamp. 				
CAUSE:	Rear lamp assembly

This bulletin involves water testing the rear tail lamps and replacing if needed.

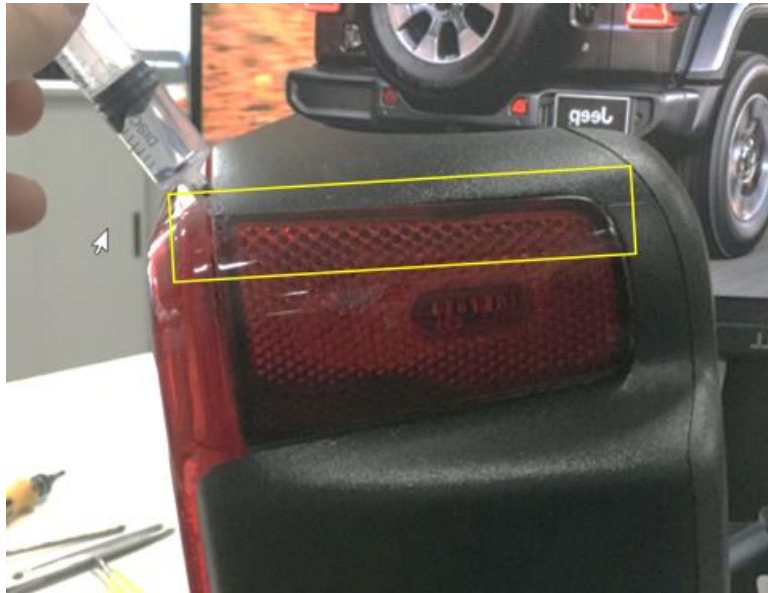
1. Apply water at the corner of the upper side marker. Make sure applied water covers all of top lens corner and top side of lens (Fig. 1) .

Fig. 1
Location of Water Intrusion Area

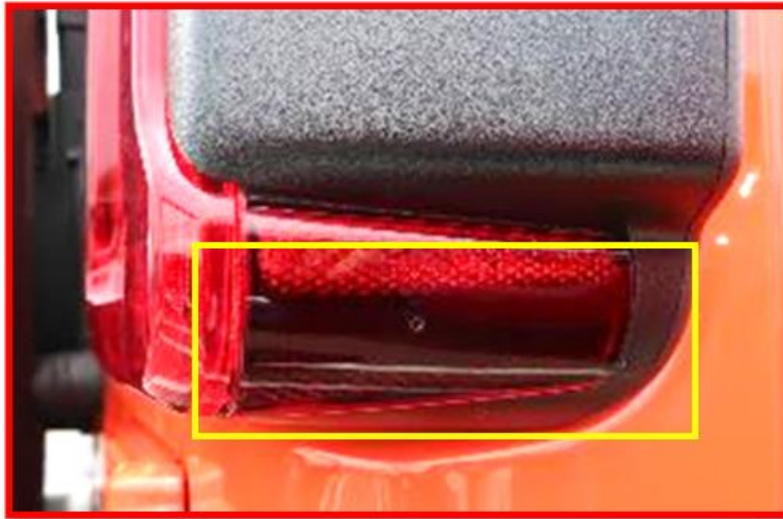
NOTE: Water intrusion into the tail lamp side marker area will appear as a dark spot (Fig. 3) and side marker is clear without water intrusion (Fig. 2) .

**Fig. 2
Water Intrusion Side Marker**

- YES>>> Replace the tail lamp with water intrusion. Proceed to [Step 3](#).
 - NO>>> This bulletin has been completed, use inspect LOP (08-50-85-9D) to close the active RSU.
3. Only replace the tail lamp with water intrusion. Refer to the detailed service procedures available in DealerCONNECT> Service Library under: Service Info> 08 - Electrical / 8L - Lamps and Lighting / Lamps/Lighting - Exterior / Lamp, Tail Stop Turn / Removal and Installation.

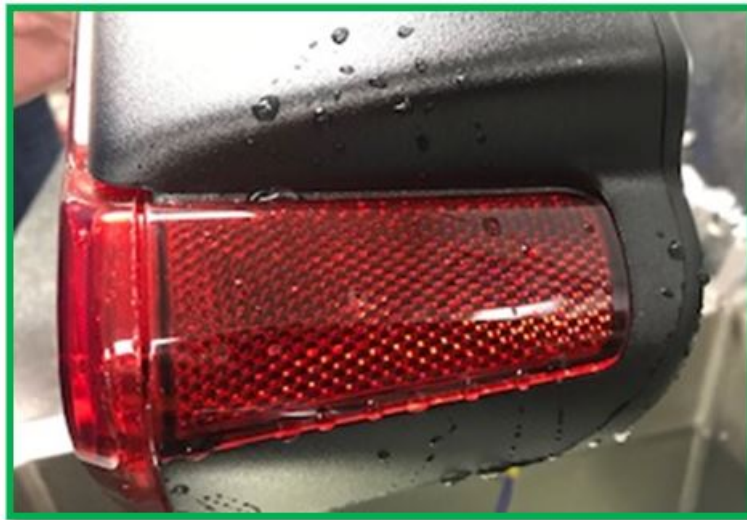
**Fig. 3
No Water in Side Marker**
