<b>REFERENCE:</b>	<b>TSB:</b> 08-024-23 <b>GROUP</b> 08 - Electrical	<b>Date:</b>	January 26, 2023	<b>REVISION:</b>	—
<b>VEHICLES AFFECTED:</b>	<p>2022 - 2023 (M1) Jeep Compass 2021 - 2023 (B1) Jeep Renegade 2022 - 2023 (H1) Jeep Commander</p> <p>This bulletin applies to M1 vehicles built on or after June 09, 2021 (MDH 0609XX) and on or before October 15, 2022 (MDH 1015XX) equipped with one of the following radios: This bulletin applies to B1 vehicles built on or after January 04, 2021 (MDH 0104XX) and on or before September 24, 2022 (MDH 0924XX) equipped with one of the following radios: This bulletin applies to H1 vehicles built on or after October 20, 2021 (MDH 1020XX) and on or before October 14, 2022 (MDH 1014XX) equipped with one of the following radios:</p> <ul style="list-style-type: none"> <li>• Uconnect 5 w 7" Display (Associated non-ICS) (Sales Code UPA).</li> <li>• Uconnect 5 w 7" Display (Sales Code UPB).</li> <li>• Uconnect 5 w 7" Display (Associated ICS) (Sales Code UPC).</li> <li>• Uconnect 5 w 8.4" Display (Associated) (Sales Code UPD).</li> <li>• Uconnect 5 w 8.4" Display (Associated Flush) (Sales Code UPE).</li> <li>• Uconnect 5 w 10.25" Display (Disassociated) (

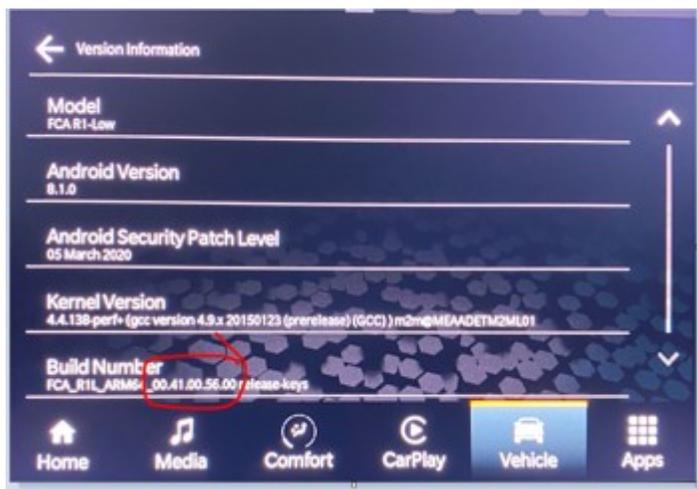
**Fig. 1**  
**Software Version**

1. Verify the software version by following these steps:
  - On the radio display screen go into “Vehicle Settings”.
  - Select “System Information”.
  - Select “Version Information”.
  - Under the “Build Number”, radio software version is listed. For example, the software version here is 00.41.00.56.00 (Fig. 1) .

2. Is the radio software version at or higher than what is listed below?
  - B1 - 47.00.15
  - M1 - 45.06.06
  - H1 - 47.00.16
  - YES>>> The radio software is up to date, this bulletin has been completed. Use inspection LOP (18-60-03-9L) to close the active RSU.
  - NO>>> The radio software needs updating. Proceed to [Step 1](#) of the Repair Procedure.
