Technical Service Bulletin (TSB)
Second Row Armrest Cap Loose Or Missing

REFERENCE:	TSB: 23-012-23 GROUP 23 - Body	Date:	January 27, 2023	REVISION:	-
VEHICLES AFFECTED:	2022 (WS) Grand Wagoneer/Wagoneer Built on or after March 8, 2021 (MDH0308XX) and on and before February 19, 2022 (MDH0219XX) equipped with Second Row Bucket Seats/Power Tip/Slide Recline (Sales Code CF5), Seven Passenger Seating (Sales Code CYE) and without Full Length Premium Floor Console (Sales Code CM5).	MARKET APPLICABILITY:			
CUSTOMER SYMPTOM:	Second row armrest cap loose/missing.				
CAUSE:	<ul style="list-style-type: none"> Defective plastic plug.

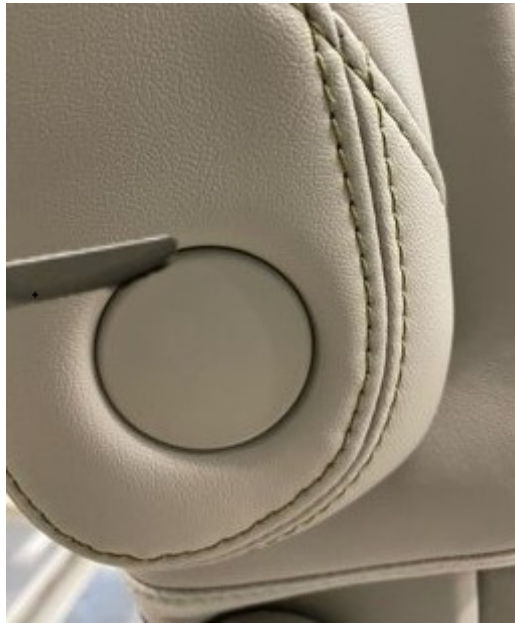
Fig. 1
Checking Gap With Go-No-Go Gauge

1. Check the gap between the armrest and plastic cap. Is there a gap? (Fig. 1)

- YES>>>Proceed to [Step 2](#).
 - NO>>>This bulletin has been completed, use inspect LOP (23-14-19-91) to close the active RSU.
2. Assure the cap is fully seated. Feeler gauge should show no gap between plastic cap and arm rest.
 3. If the gap remains after attempt to fully seat, replace cap.
 4. Verify any other customer seat concerns with the latest available bulletins. Refer to all applicable published service bulletins for detailed repair procedures and labor times regarding updating the seat concerns.
