NUMBER: 23-011-23

DATE: January 27, 2023

Front Floor Center Console Surface Feels Warm

2021 - 2022 (WL) Jeep Grand Cherokee/Grand Cherokee L

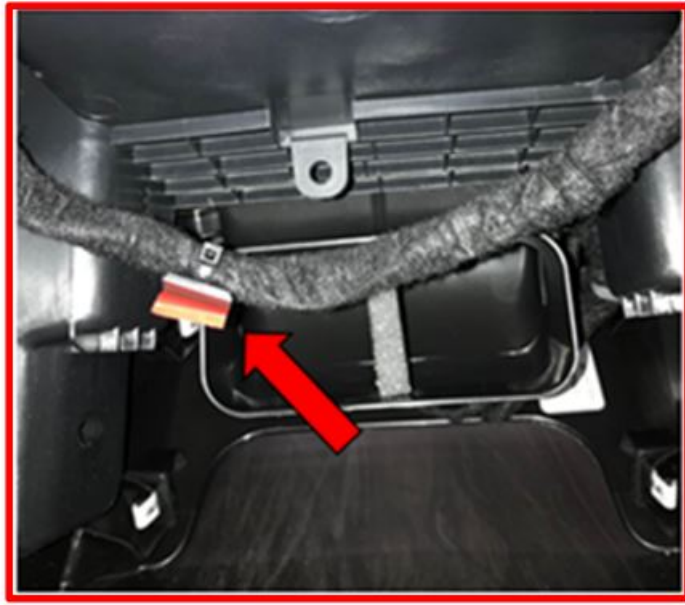
Fig. 4
Retainer Clip Not Attached

2. Check if there is a wire harness retainer is properly attached to the underside of the console (Fig. 4) .

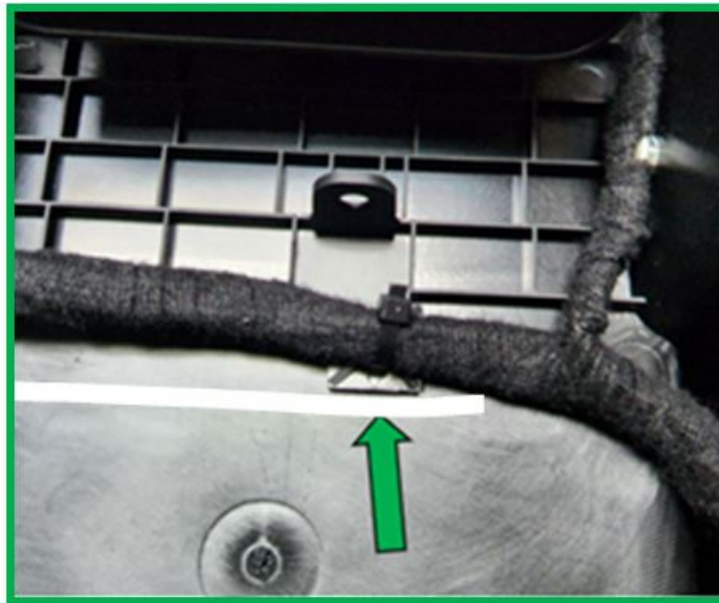
Fig. 5
Retainer Clip Properly Attached

3. If retainer clip is not attached, peel off paper from adhesive and stick retainer clip to the underside of the console (Fig. 5) .
