GLOBAL SAFETY FIELD INVESTIGATIONS  
DCS6449  
URGENT - DISTRIBUTE IMMEDIATELY

Date: February 16, 2023  
Subject: N232395320 - Special Coverage  
Camshaft Cover  
Models: 2019 Buick Cascada  
To: All General Motors Dealers

# Special Coverage Adjustment

## N232395320 Camshaft Cover

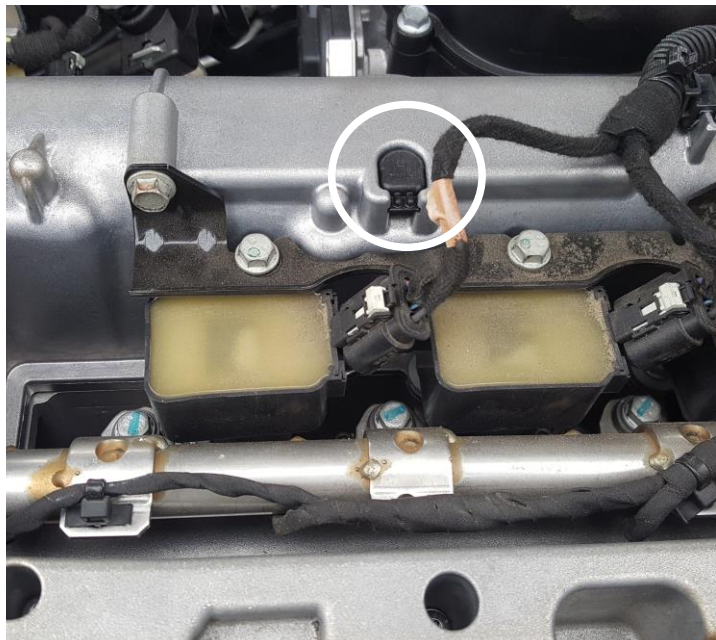
5509278

<b>Condition</b>	Some 2019 Buick Cascada vehicles equipped with a 1.6L engine may have a condition where cracks can develop in the diaphragm of the Positive Crankcase Ventilation (PCV) pressure regulator valve. This valve is a part of the engine camshaft cover. If this were to occur, excess air could be drawn into the engine intake. As a result, the engine may run rough, especially during idle, the Malfunction Indicator Light (Check Engine Light) would illuminate and a diagnostic trouble code for Fuel Trim Lean (P0171) or other airflow related DTC would set.
<b>Special Coverage Adjustment</b>	<p>This special coverage covers the condition described above for a period of 15 years or 150,000 miles (240,000 km), whichever occurs first, from the date the vehicle was originally placed in service, regardless of ownership.</p> <p>For vehicles covered by Vehicle Service Contracts, all eligible claims with repair orders on or after February 16, 2023, are covered by this special coverage and must be submitted using the labor operation codes provided with this bulletin. Claims with repair orders prior to February 16, 2023, must be submitted to the Service Contract provider.</p> <p>Vehicle owners or lessees who paid for repairs referenced in this Special Coverage ("Customers") are eligible for reimbursement of their reasonable and customary expenses in accordance with the procedures specified below. The conditional right to reimbursement is provided by GM solely in the interest of customer satisfaction and is personal to Customers. <i>Customers may not assign and GM does not consent to any assignment of any Customer's right to submit reimbursement claims, or to receive reimbursement, or any other rights granted by this Special Coverage to any third party, including but not limited to service contract providers, and this Special Coverage is not intended to and does not confer any third party beneficiary, subrogation or contribution rights, or any other rights to reimbursement, against GM, whether in law, equity or otherwise, on any third parties.</i></p>

- 2.3 With the engine running, listen for noise coming from the PCV valve, shown above. If noise is heard, check to see if the noise gets quieter or disappears with the engine oil dipstick removed.

- If the PCV valve is making noise and there is vacuum present at the PCV valve vent, replace the Camshaft Cover. Refer to *Camshaft Cover Replacement* in SI.
- If the PCV valve does NOT make noise or leak vacuum, no further diagnosis or repair is covered under this special coverage. Claim diagnostic time and inform the customer that any further diagnostics or repair will have to be covered by customer pay, warranty, or good will.
