GLOBAL SAFETY FIELD INVESTIGATIONS  
DCS6453  
URGENT - DISTRIBUTE IMMEDIATELY

Subject: REVISION: N212355140-01 – Service Update  
Diesel Engine Control Module Diagnostics  
Updated Warranty Period, Title, and Condition Statement

Models: 2021-2022 Cadillac Escalade, Escalade ESV  
2021-2022 Chevrolet Suburban  
2021-2022 Chevrolet Tahoe  
2021-2022 GMC Yukon, Yukon XL  
Equipped with 6-cylinder, 3.0L Diesel engine (RPO LM2)

## N212355140 Diesel Engine Control Module Diagnostics

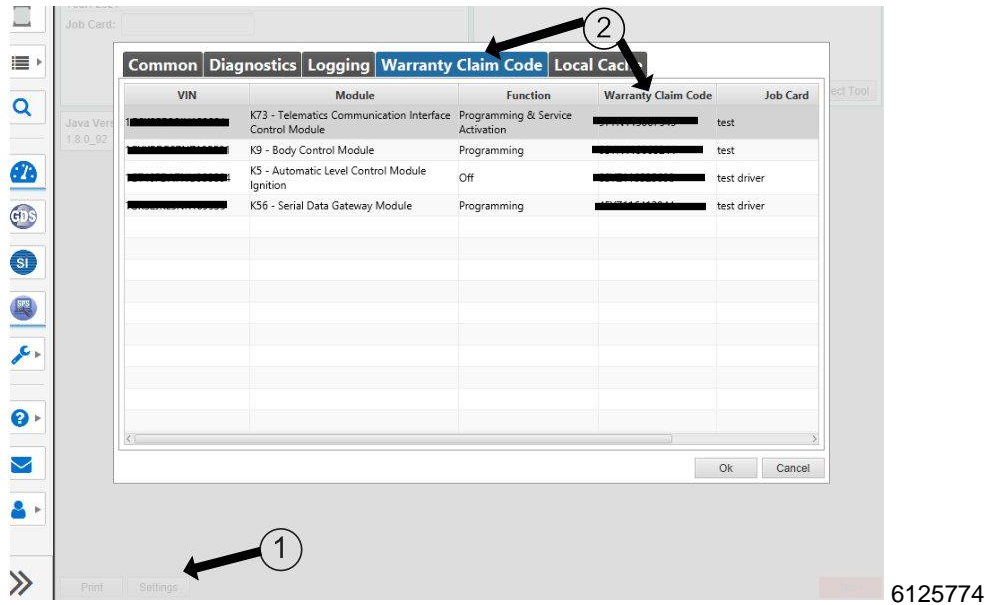
If the Warranty Claim Code was not recorded on the Job Card, the code can be retrieved in the SPS2 system as follows:

1. Open TLC on the computer used to program the vehicle.
2. Select and start SPS2.
3. Select Settings (1).
4. Select the Warranty Claim Code tab (2).

The VIN, Warranty Claim Code and Date/Time will be listed on a roster of recent programming events. If the code is retrievable, dealers should resubmit the transaction making sure to include the code in the SPS Warranty Claim Code field.

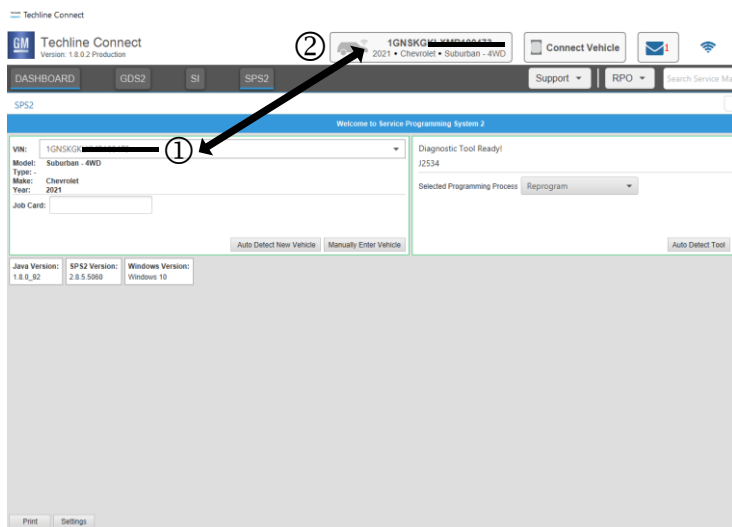
5743643

**Caution:** Be sure the VIN selected in the drop down menu (1) is the same as the vehicle connected (2) before beginning programming.

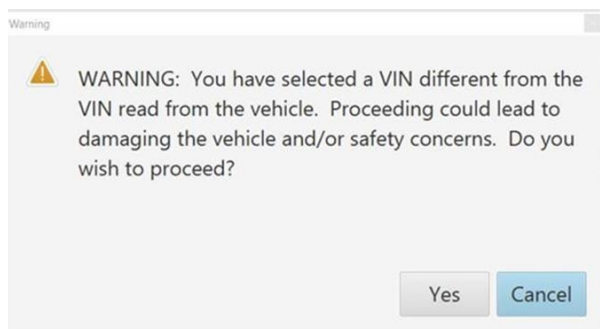
5877000

**Important:** If the vehicle VIN DOES NOT match, the message below will be shown.

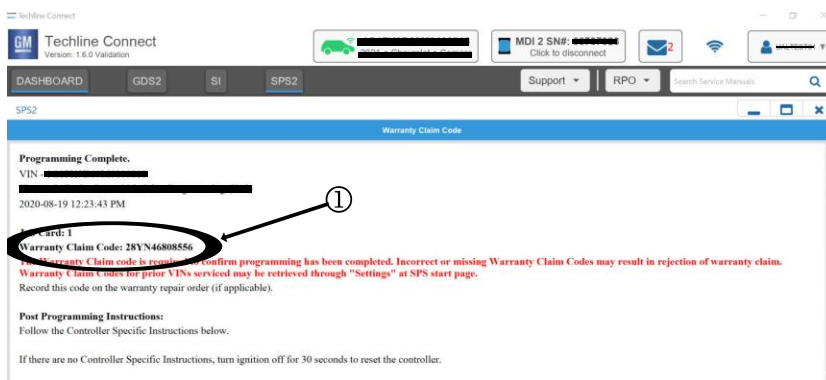
5644478

**Important:** To avoid warranty transaction rejections, you **MUST** record the warranty claim code provided on the Warranty Claim Code (WCC) screen shown above on the job card. Refer to callout 1 above for the location of the WCC on the screen.

2. Record SPS Warranty Claim Code on job card for warranty transaction submission.
