TECHNICAL SERVICE BULLETIN

Classification: AN23-004	Reference: NTB23-012	Date: February 1, 2023
-----------------------------	-------------------------	---------------------------

SOFTWARE UPDATE FOR INFOTAINMENT ISSUES

APPLIED VEHICLES: 2022-2023 Pathfinder (R53)

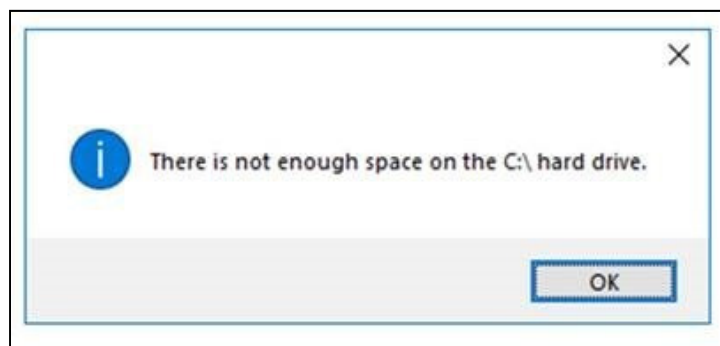
Figure 8

- The update-software is estimated to take 4 hours to download to the USB drive.
- If, while attempting to download the software to the CONSULT PC, you receive the message shown in Figure 8:
 - Attempt to clear space on the CONSULT PC hard drive.

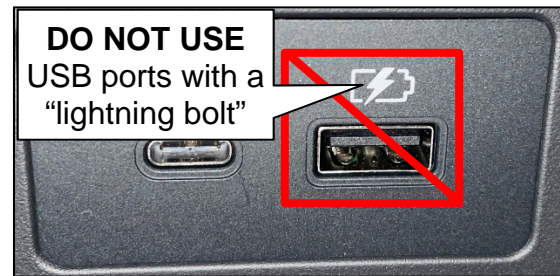
Figure 12

Do not insert the USB drive into a charging port. If used, the update-software and/or USB drive may become damaged. Only insert the USB drive in a USB media port.

HINT: Charging ports are marked in the vehicle with a “lightning bolt” symbol (Figure 12).
