STE Hackney

**SERVICE BULLETIN:**

**230214**

**Red Bull Bumpers**

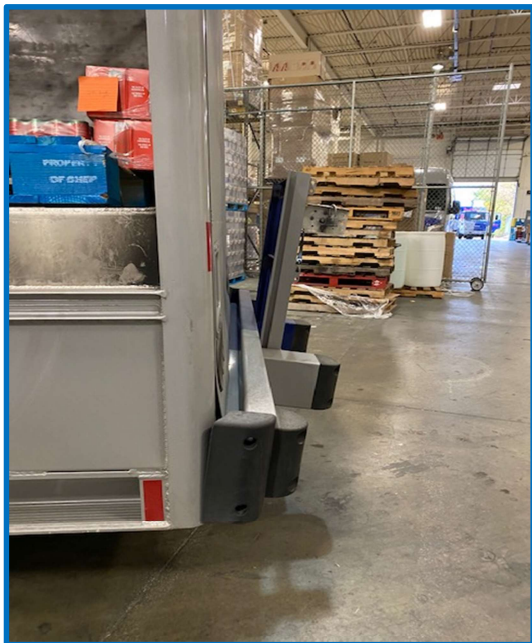
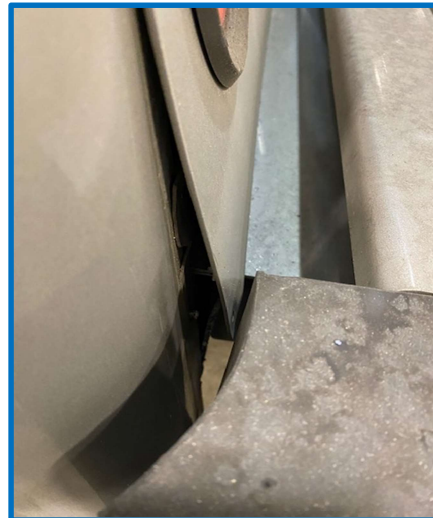
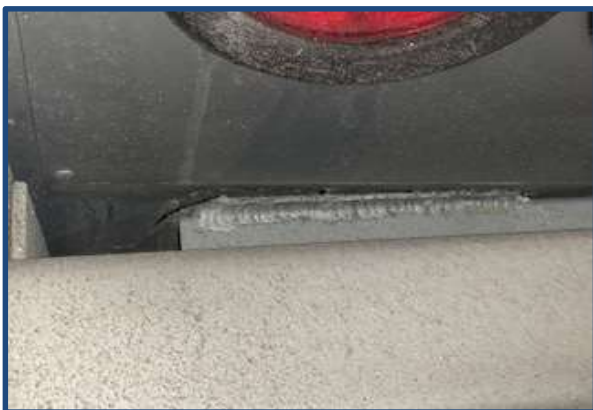
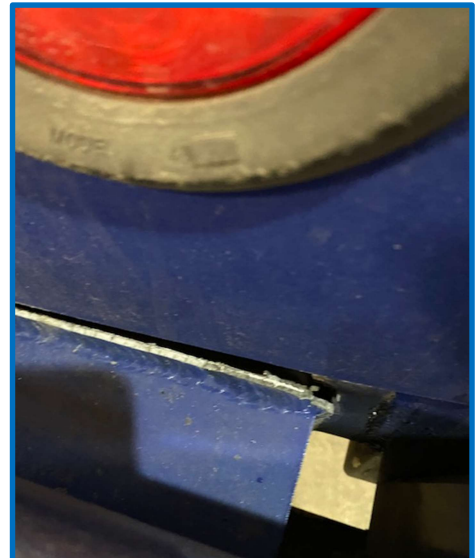
Some 2016 - 2018 Red Bull units have experienced cracking around the welds that secure the rear bumper to the rear frame. The cracking is caused by the forces applied by the rear bumper with loaded hand cart rack under repeated use. Engineering changes were made in 2018 (West) and 2019 (East) units to stiffen the internal rear frame and bumper structure.

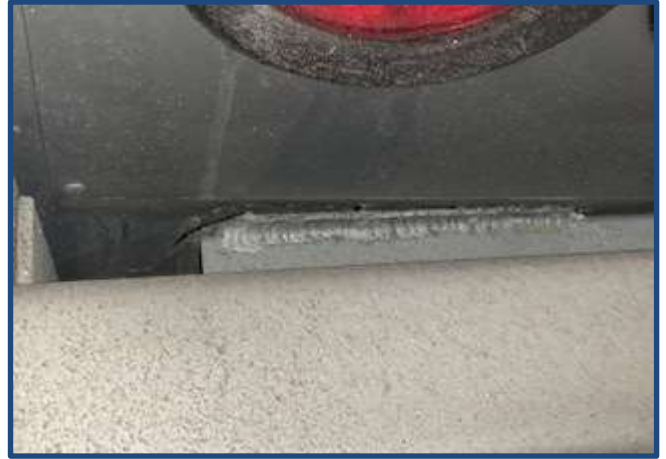
### 1. Inspection

Inspect the bumper for cracking at welded attachment to the rear frame.

**IF cracks evident** = contact Hackney warranty. We will review and arrange for repairs.
