Service Bulletin

Bulletin No.: 22-NA-229

Subject: Possible Audible Knock Due to Reduced Knock Sensor Detection Capability DTC P0325, P0330, P0326, P0331, P06B6 or P06B7 May be Set in History

Brand:	Model:	Model Year:		Break Point:		Engine:	Transmission:
		from	to	from	to		
Cadillac	Escalade	2023	2023		December 5, 2022	6.2L RPO (LT4)

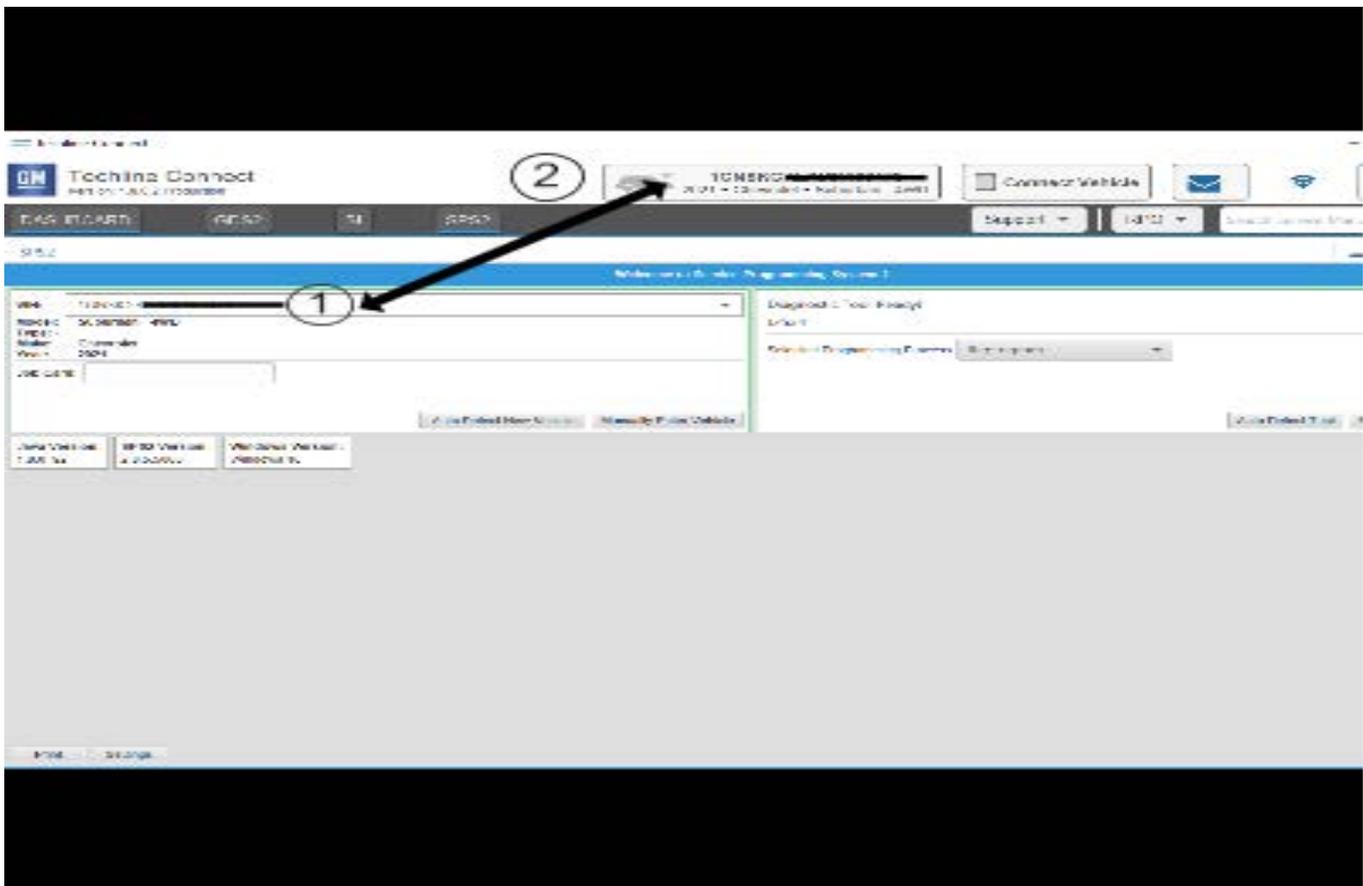
Caution: Be sure the VIN selected in the drop down menu (1) is the same as the vehicle connected (2) before beginning programming.
