**From:** [REDACTED]  
**Sent:** Wednesday, January 18, 2023 5:14 PM  
**To:** [REDACTED]  
[REDACTED]  
[REDACTED]  
**Subject:** Remote fuel hose/ PN 6316754

# Screening Instructions- Remote Fuel Line

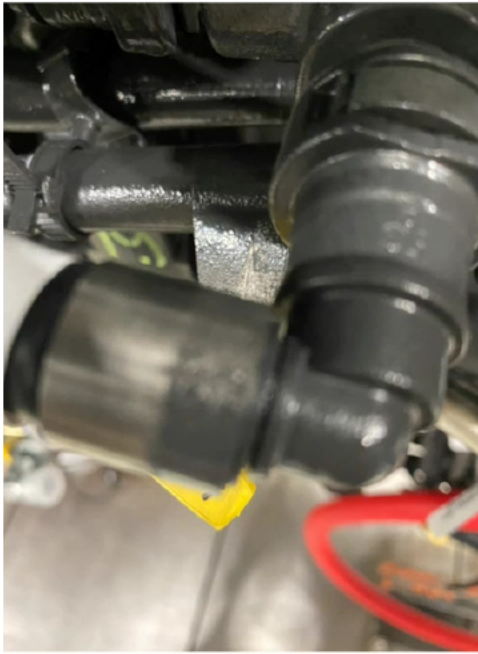
- One pager shared for the 6 defects associated with the remote fuel filter line PN 6316754.
- Based on the discussion and the picture shared for the fuel hose below, we have requested a feedback from the supplier to let us know the acceptance criteria for the gap between the crimp and the fitting [REDACTED] [REDACTED] please hold off on the inspection until then. We will try to have the feedback from the supplier asap.

- [REDACTED], please go ahead and check one of the fuel hoses in the oven to see the effect of the temperature on the crimping.
- In case if the defective part is found, both the hoses are to be changed in that case for the engine.
- [REDACTED], please find the list of the affected ESN. Could you please provide the list of the ESN at the site and the ones released to the field.
- Instructions to be shared by [REDACTED] the checks that are to be performed with [REDACTED].

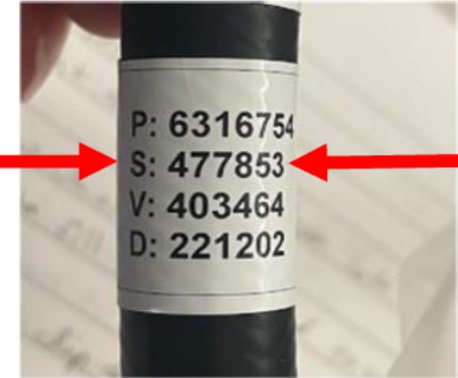
Figure 1

- Please refer to the file for the list of suspect engines which are shipped to PACCAR
- Please use the tracking info sheet
- Note down the ESN
- Confirm the P/N 6316754 on the remote fuel lines.
- Confirm the batch code on the fuel lines (2<sup>nd</sup> number on the tag which is referenced as S:477853. Refer to the Figure 1)
- Remove the remote fuel line from the engine. Beware of fuel spillage. Please ensure bucket is used for the excess fuel coming out from the fuel line.
- All the check are to be satisfied to deem the hose acceptable.
- **GAP CHECK**
  - Verify gap between the plastic connector and the hose end is not greater than 2mm (refer to fig 2).
  - Check both ends.
  - Record pass/fail in spreadsheet

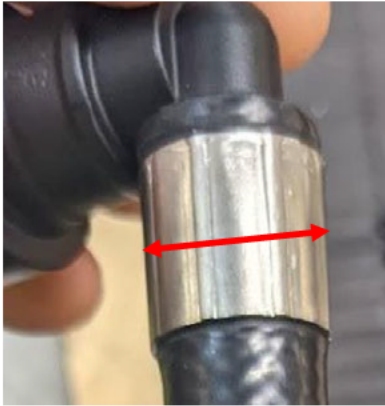
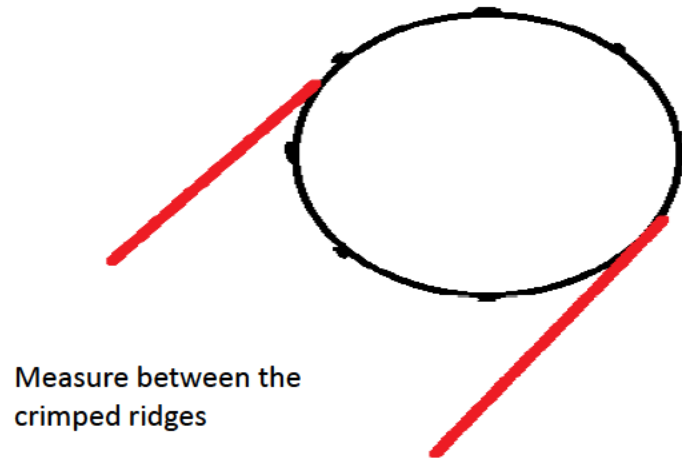
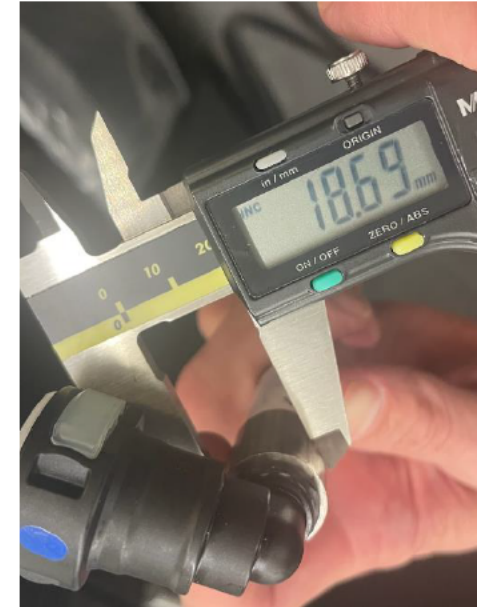
# Measure with Calipers

- Measure the crimp diameter, between the ridges on the flat area of the crimped sleeve.
- Specification 18.7mm +/- 0.2mm (18.5 to 18.9mm)
- Record measurement of each end.

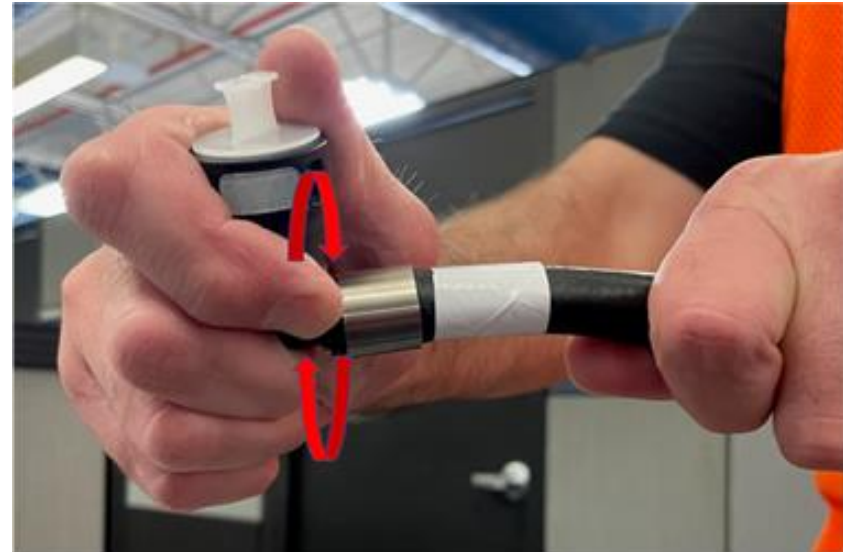
# Twist Test

- Twist each end clockwise and counterclockwise by roughly 45 degrees
- If any rotation is observed from the plastic end connector in the hose the part should be rejected.
- Note on spreadsheet pass/fail

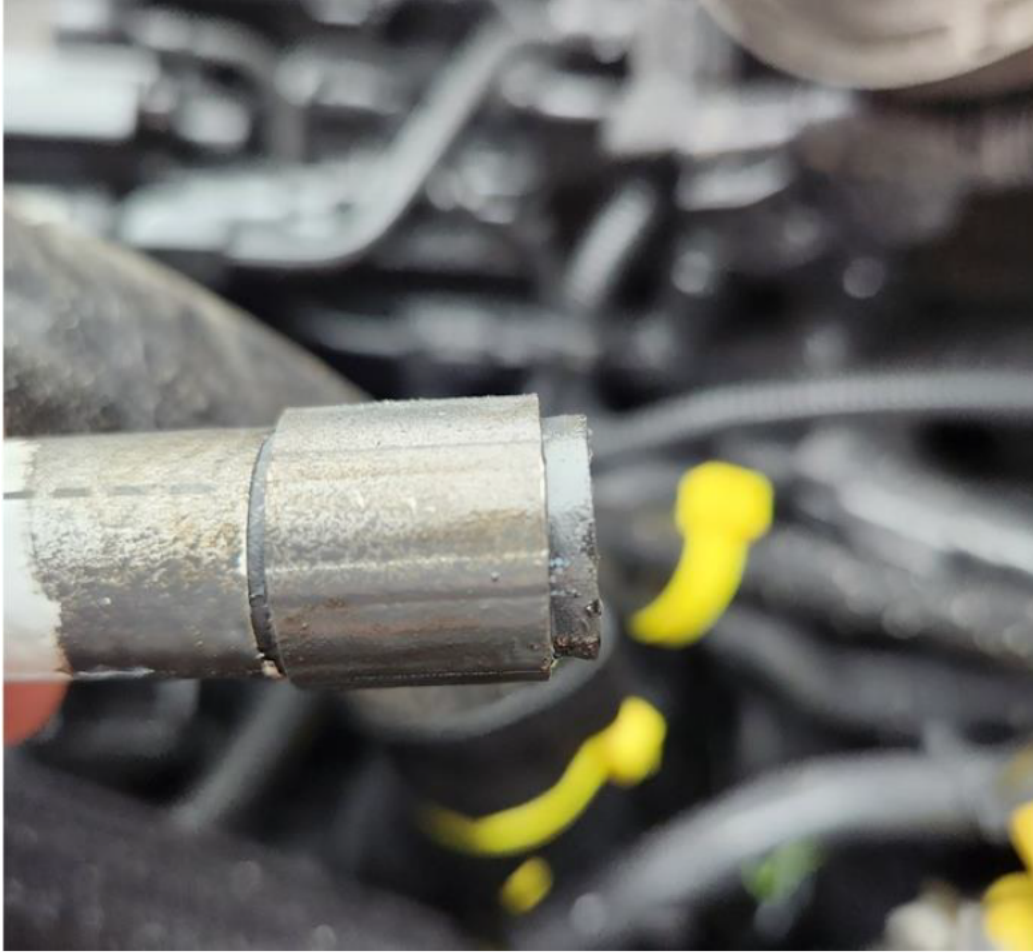
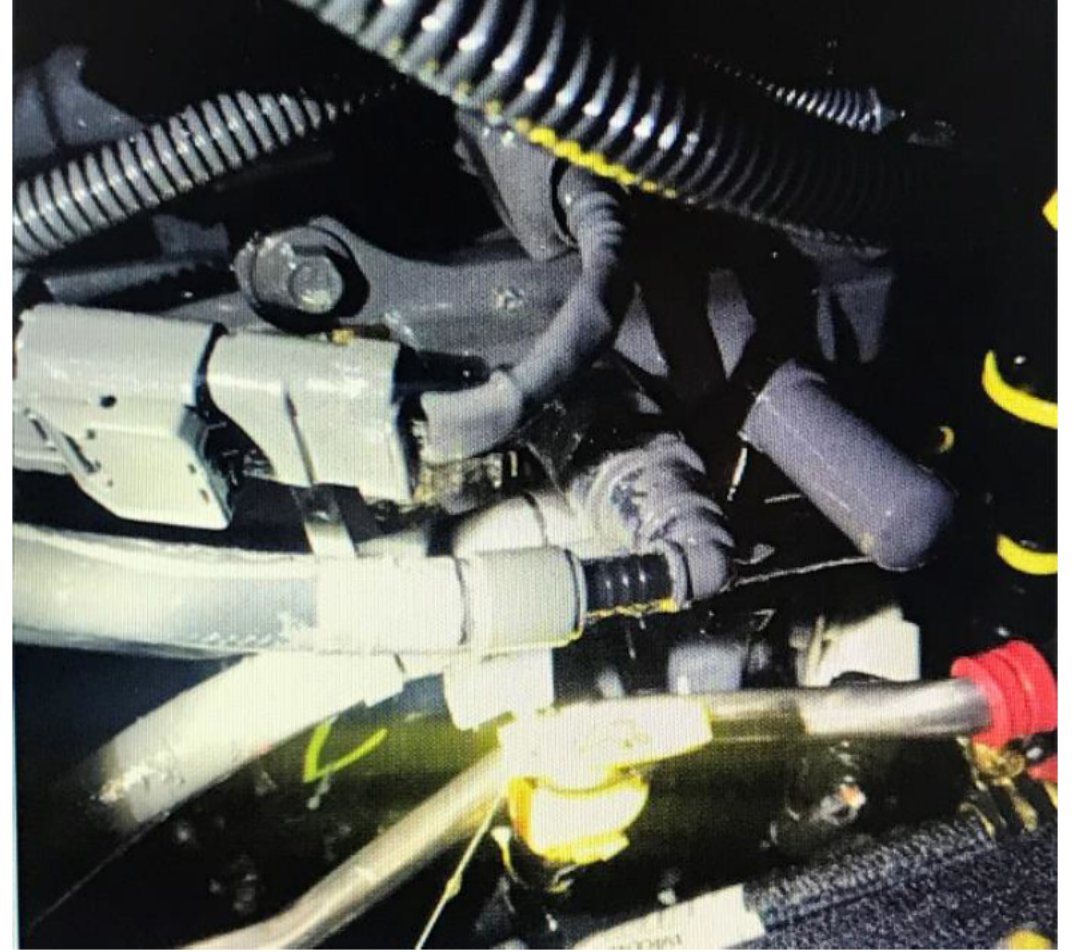
# Failures detected

- Fuel leak on remote fuel line (low pressure side).

- TBD – Awaiting failed parts return.
- Suspect assignable cause is insufficient crimping. – Returned parts will be analyzed to validate suspect assignable cause.
