Technical Service Bulletin

01 Engine Crankcase breather Whistling Noise and DTC P227900 warning light ON

01 23 44 2069351/2 February 13, 2023. Supersedes Technical Service Bulletin Group 01 number 23-43 dated February 7, 2023, for reasons listed below.

Model(s)	Year	VIN Range	Vehicle-Specific Equipment
A8	2019 – 2022	All	Not Applicable
S8	2020 – 2022		
RS 6, RS 7, SQ7, SQ8, and RS Q8	2021 – 2022

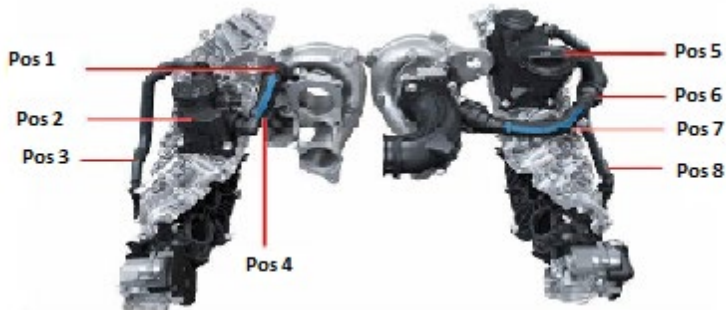
- Exhaust warning light is ON.

- A whistling noise can occasionally be heard from the engine compartment.

- DTC P227900 Intake Air System.
- DTCs connected to misfires may be present on bank 2.

Item 4: Full load breather line (Replacement required)

In this case, replace the full load breather line for cylinder bank 1.

1. Do not replace the oil separator for bank 1 or bank 2 or the part load breather lines.
2. Please refer to image of the crankcase breather from the Self Study Program 920493 as a guide.
