01 "Switch off the engine and check coolant" message in the instrument cluster, DTC P00000 is stored in the ECM

01 23 46 2058890/4 February 20, 2023. Supersedes Technical Service Bulletin Group 01 number 20-91 dated October 7, 2020, for reasons listed below.

Model(s)	Year	VIN Range	Vehicle-Specific Equipment
S4, S5, S5 Cabriolet, S5 Sportback, and SQ5	2018	All	Not Applicable
RS5, and RS 5 Sportback	2019

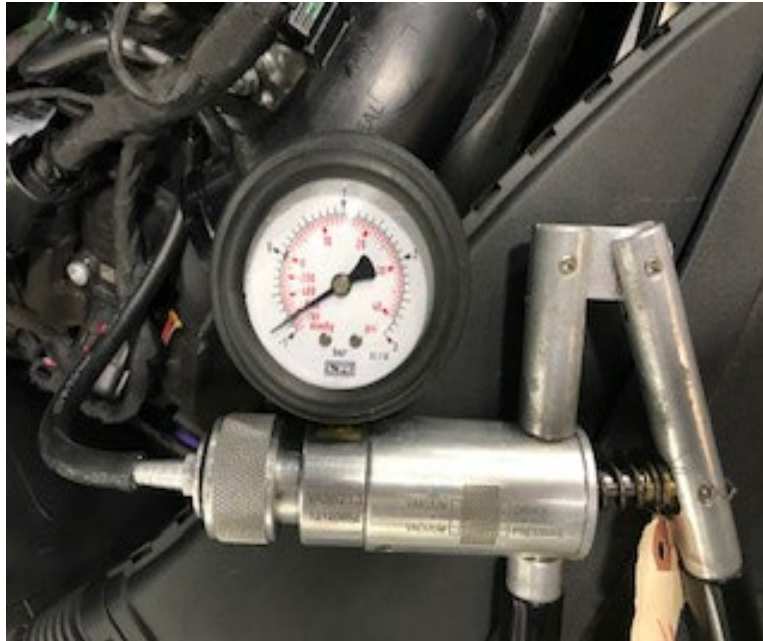
a. Check for vacuum (using VAS6213) at the output port of solenoid N649 which commands the water pump sleeve (Figures 1 and 2). The engine needs to be cold to generate a command signal to the N649 solenoid to switch to a vacuum. **With the engine cold**, start the engine briefly and monitor that vacuum is created.

Figure 1. Checking the vacuum at the output port of N649.

b. If there is no vacuum measured at the output port of N649, the cause of the fault could be related to the solenoid valve N649 or the vacuum hoses (check for leaks). In this case, repair and check the operation of the vacuum system.

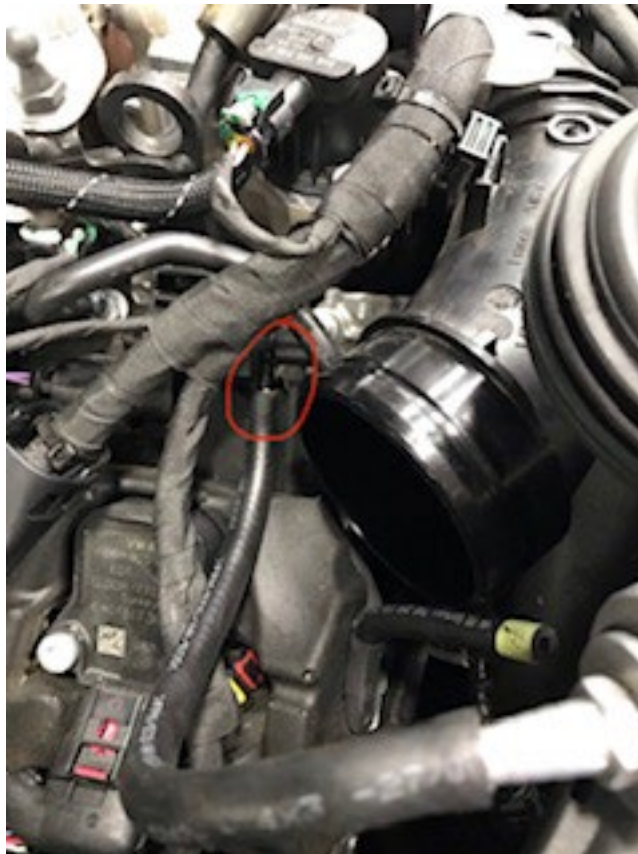
Figure 2. The output port of N649 (close-up picture).

4. If there are no malfunctions found in the vacuum system, check the operation of the water pump sleeve by applying a vacuum to the hose going to the water pump (hose connected to the output port of N649). When applying a vacuum to the pump, pay attention to the clicking sound of the water pump sleeve. If no clicking is heard or felt, replace the mechanical coolant pump.
