Service Bulletin

Bulletin No.: 19-NA-076

Subject: Blue or Black Screen and Service Rear Vision System Message on Radio Display Shifting into Reverse

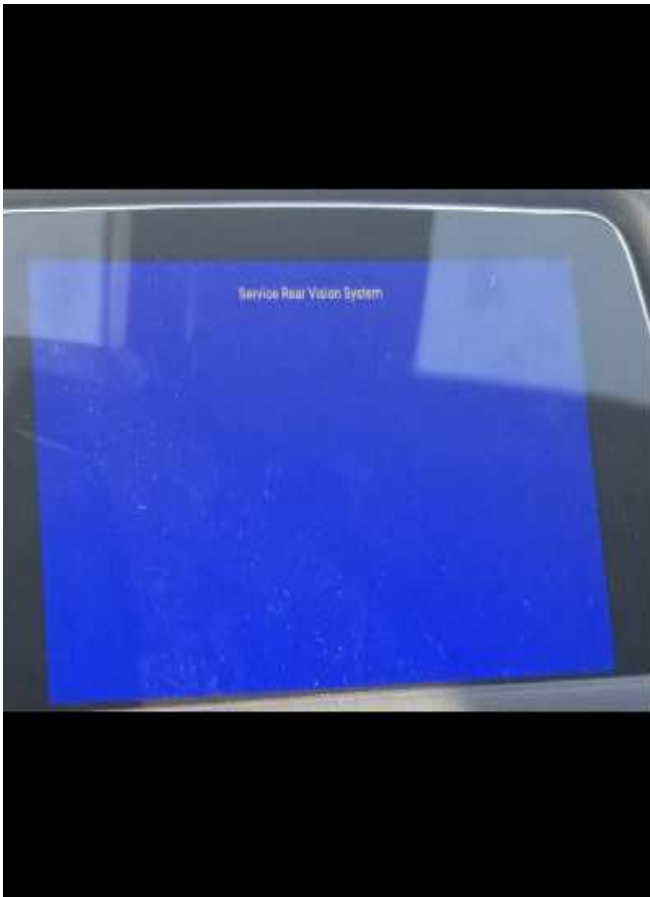
<p>5733397</p> <p>Blue Screen</p>

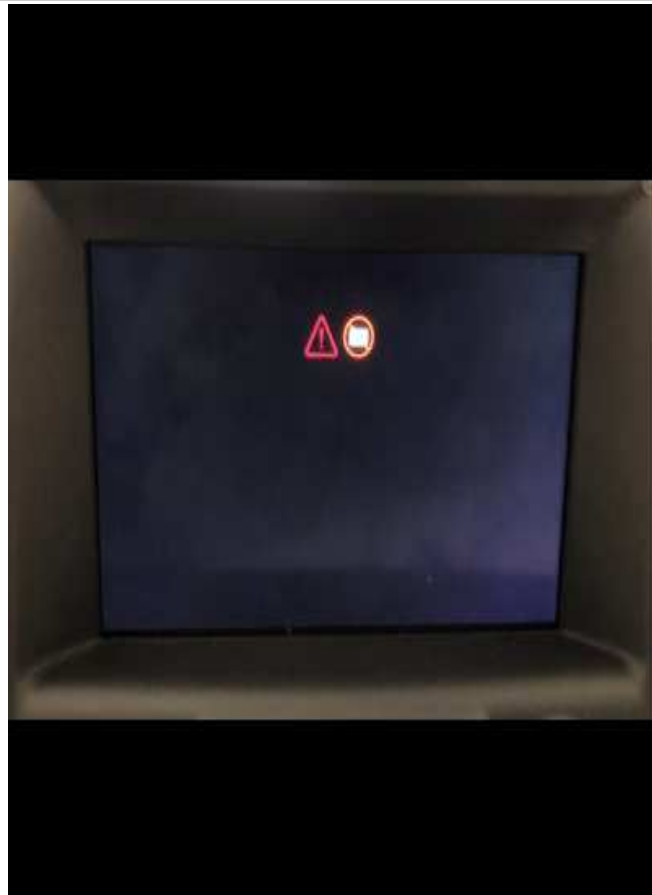
5733400

Black Screen

Some customers with select vehicles may notice that after having vehicle in idle for an extended period of time (length of time for black screen to occur depends on ambient temperature), a black screen with a red triangle and no camera icon will appear when the vehicle is put in Reverse and the camera icon will be crossed out on the radio center screen.
