# Technical Service Bulletin

## 39 Bevel box separation point is leaking

39 23 52 2059759/4 February 22, 2023. Supersedes Technical Service Bulletin Group 39 number 22-48 dated October 21, 2022, for reasons listed below.

Model(s)	Year	VIN Range	Vehicle-Specific Equipment
Q3	2015 – 2021	All	With quattro

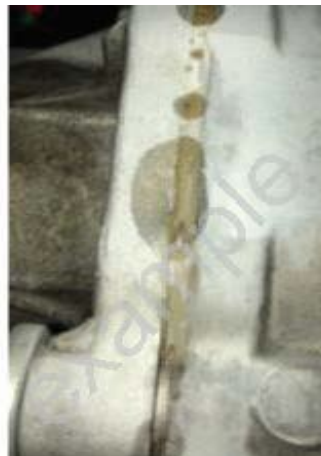
- The customer statement can be confirmed.
- The oil leak can be seen along the case seam of the bevel box (Figure 1), on the passenger side of the propeller shaft on the side facing the engine. It can be found between the two bolts in the picture below marked with arrows (Figure 2). These bolts connect the bevel box to the engine bracket (Figure 3, position 1).

**Figure 1.** Bevel box case seam leak location.

1. Remove the bevel box according to the Elsa repair manual.
2. Thoroughly clean the bevel box in the area of the case seam (Figure 1) and the two housing bolt holes (Figures 2 and 3).

3. Apply silicone sealant (part number D 174 003 M2) to the case seam (Figure 4, yellow arrows). Apply a continuous seam of the silicone with a width of about 10 mm (Figure 4, red lines) and a height of about 3 mm.

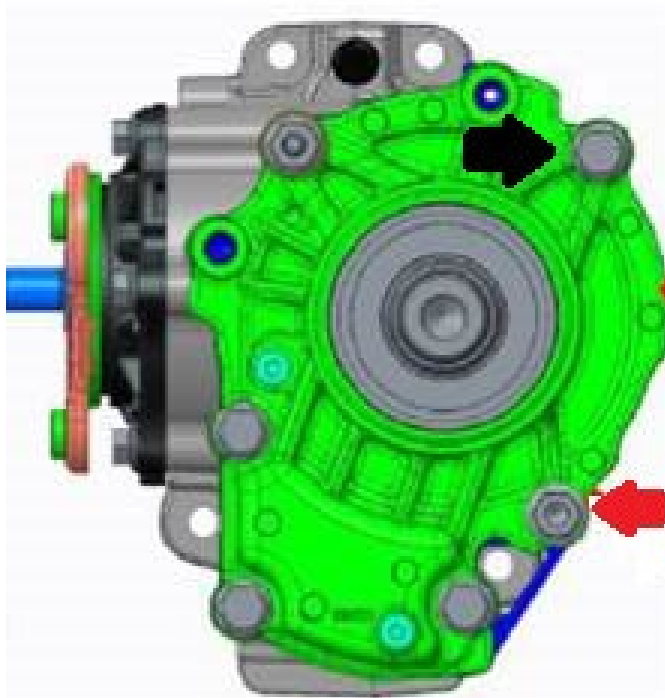
*Figure 2. Bolt locations.*

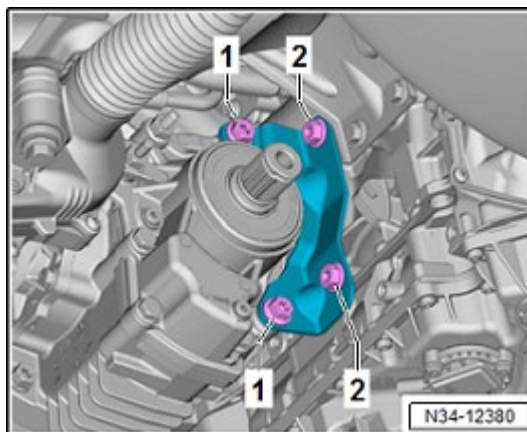
*Figure 3. Bolt locations position #1.*

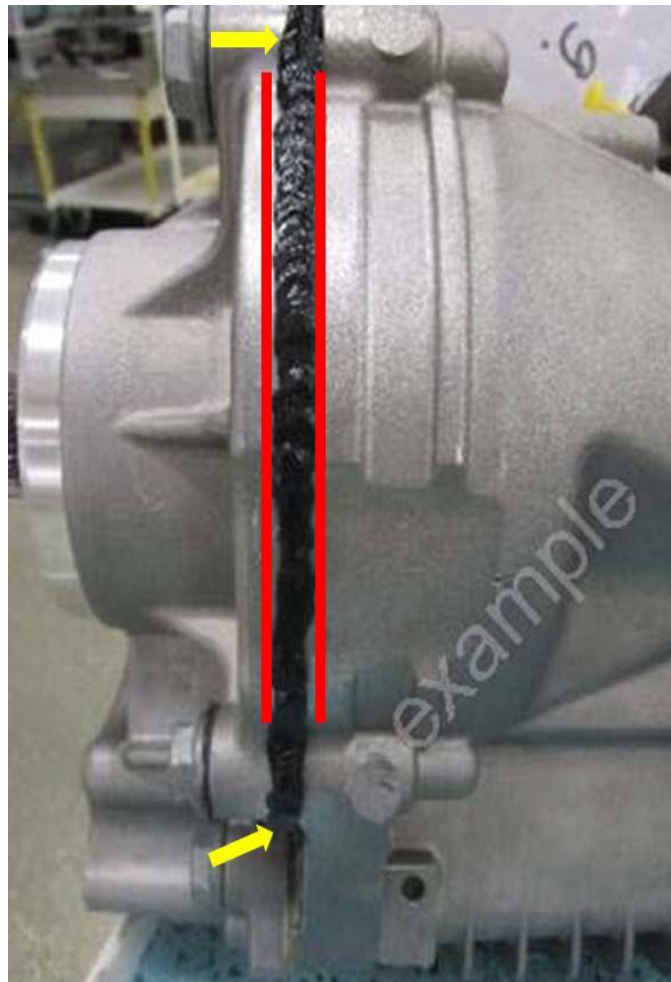
*Figure 4. Silicone sealant application.*

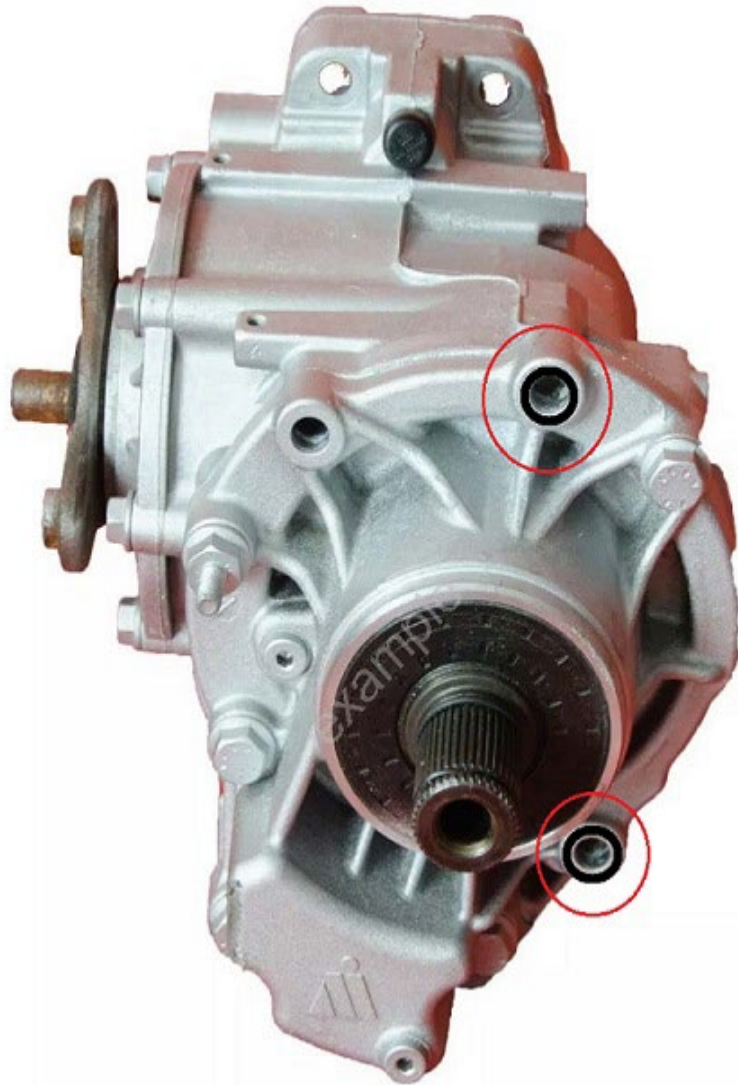
**Figure 5.** Silicone sealant at bolt holes.

4. Apply silicone sealant (part number D 174 003 M2) continuously to the holes of the housing bolts just before installation (Figure 5, red circles).

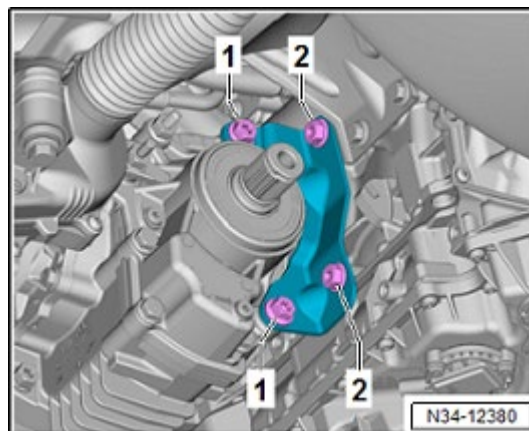
**Figure 6. Bolts and engine bracket.**

5. Continuously apply the silicone sealant to the shoulder of the removed housing bolts just before installation to form a seal at the engine bracket (Figure 6, position 1).
