# Technical Service Bulletin

## 57 Exterior door handles do not return to the zero position

57 23 01 2060196/4 February 21, 2023. Supersedes Technical Service Bulletin Group 57 number 21-80 dated July 26, 2021, for reasons listed below.

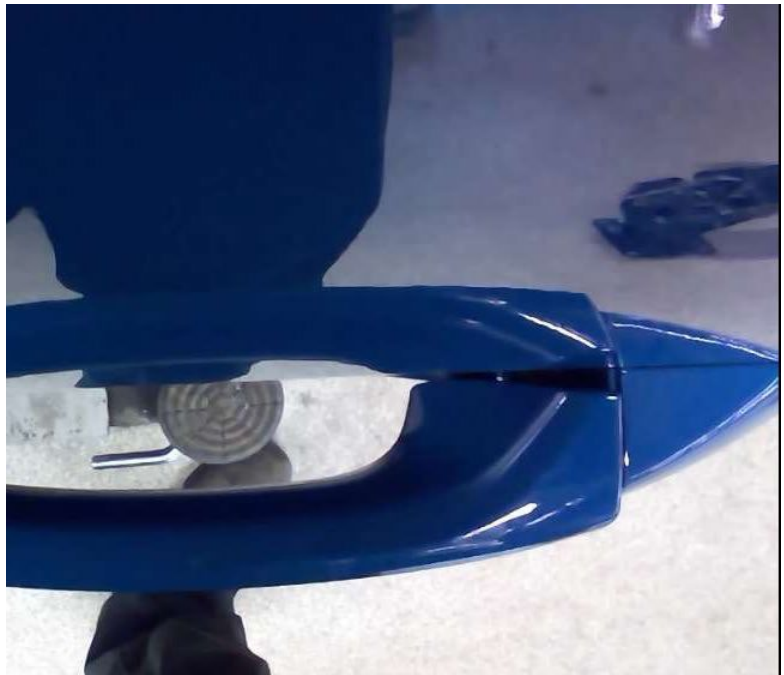
- Exterior door handles are binding and are not returning to the zero position.

Due to material tolerances, the door handle guide is binding within the door handle mounting bracket.

**Figure 1.** Door handle binding and not returning to zero position.

1. Check the function of all door handles. Door handles should return to the zero position without binding and/or jamming (Figure 1).

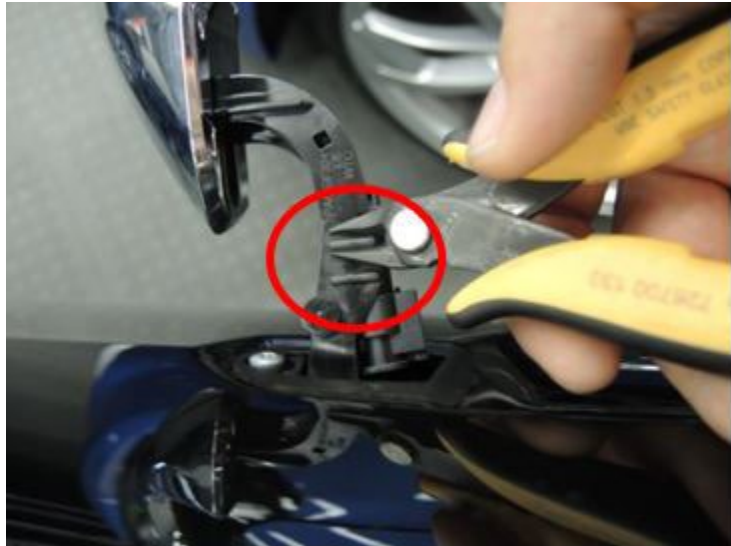
**Figure 2.** #1 and #2 door handle ribs prior to removal.

- Using precision diagonal cutting pliers, remove door handle rib #1 and #2 on the pivot side of the mounting bracket, toward the front of the vehicle (Figure 2).

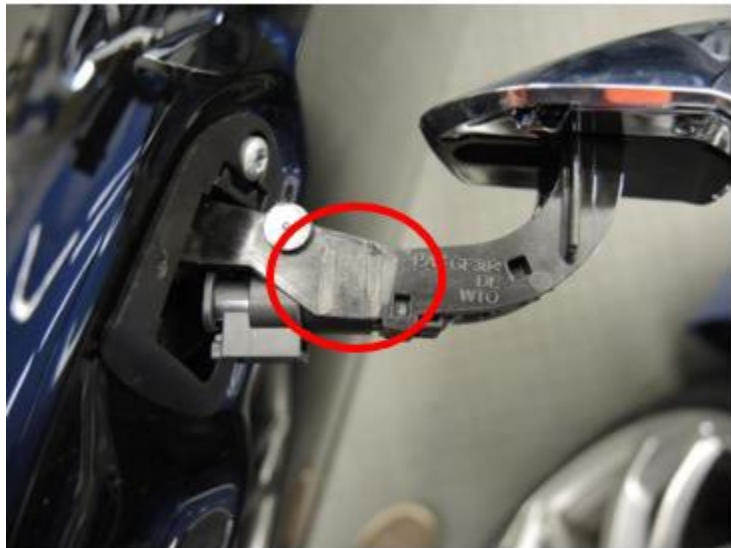
**Figure 3.** The door handle is shown with #1 and #2 ribs removed, leaving an even surface.

- After removing both ribs, ensure that the resulting surface is smooth and without any protrusions (Figure 3).

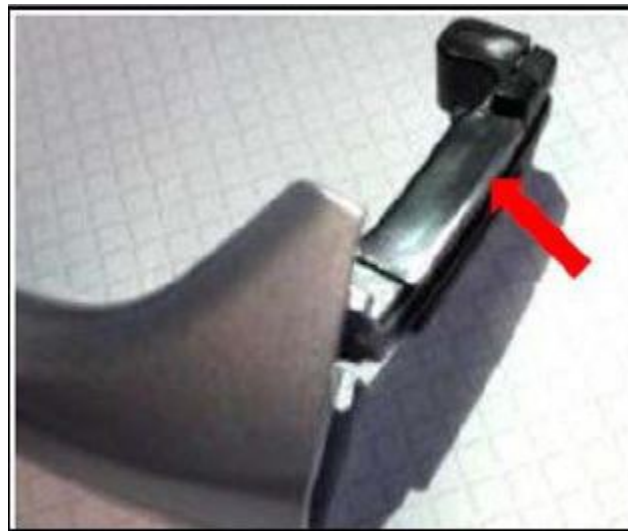
**Figure 6.** Top of rib #3 to be sanded down.

- Sand down the top surface of rib #3 with sanding paper until the door handle at rib #3 measures approximately 20.6 mm (~ 0.81 inches) (Figures 4 and 6).

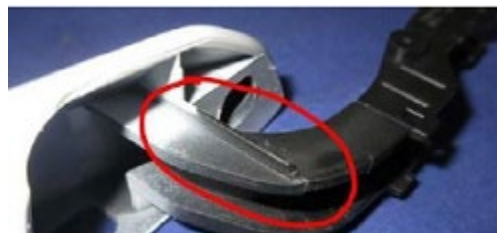
**Figure 7.** The door handle guide piece to be replaced.

8. Replace the door handle guide piece on the lock cylinder side, towards the back of the vehicle (Figure 7) with a new guide piece (check parts table for part number).
