GROUP	MODEL
ENG	2023MY Seltos (SP2)
NUMBER	DATE
242	February 2023

TECHNICAL SERVICE BULLETIN

SERVICE ACTION: COOLANT RESERVOIR CAP INSPECTION & REPLACEMENT (SA527)

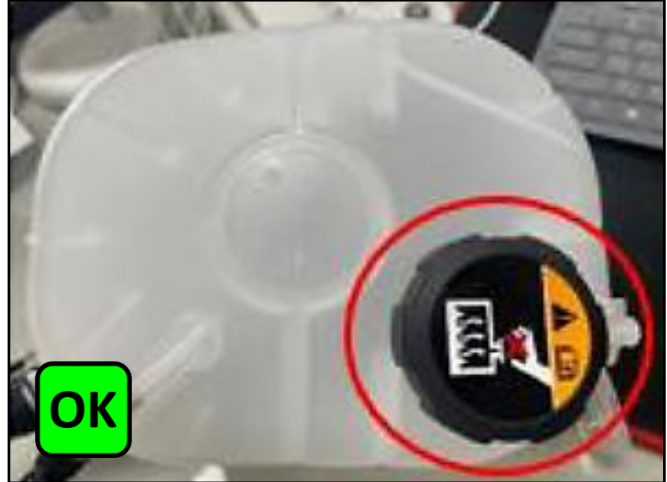
1. Inspect the coolant reservoir cap and confirm it is equipped with the correct plastic cap:
 - If the reservoir cap is the plastic type shown on the right (OK), then no further action required. This action is complete.

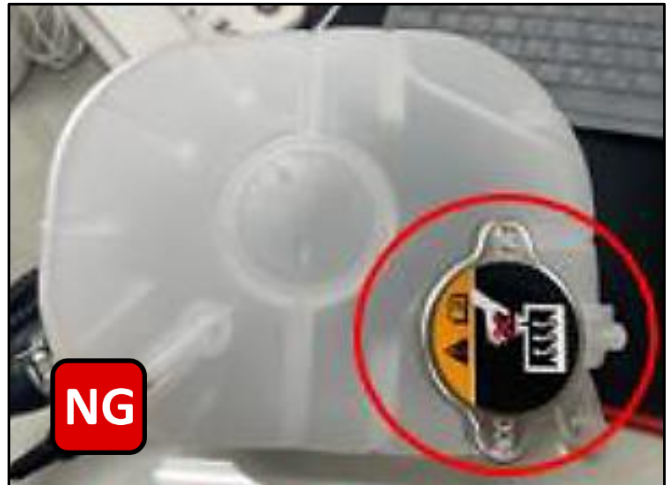
- If the reservoir cap is the metal type shown on the right (NG), then replace the coolant reservoir cap with the plastic type shown below.

Part Name	Part Number	Figure	Qty.
Coolant Reservoir Cap	25330 D9000
