Customer states one or more of the shocks/struts appear to have an oil leak.

Leaking Shock Absorber:

Shock/Strut with Minor Oil Film:

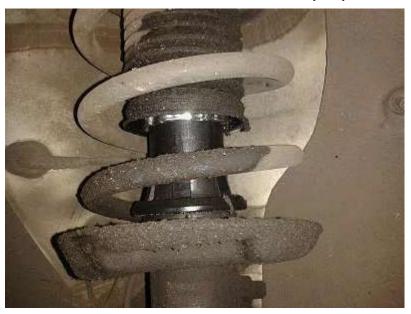
An oil residue that runs down the shock/strut body may indicate a leak (see figure 1 and 2).

Figure 1) shock/strut Leak

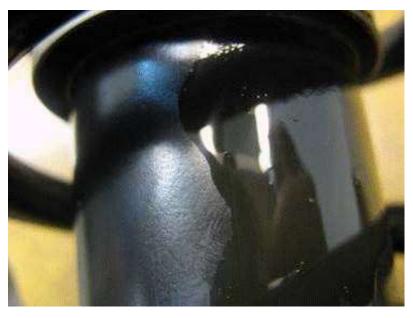
Figure 2) shock/strut leak

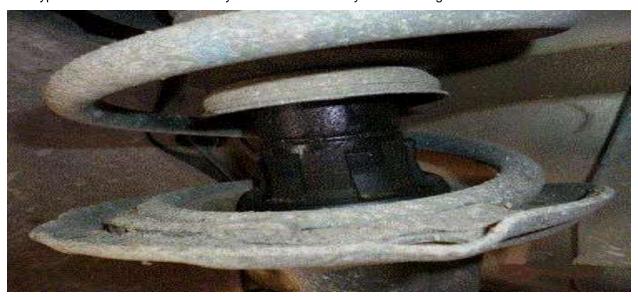
• A slightly dried oil residue at the top of the shock/strut does not indicate a leak (see figure 3 and 4). This type of residue can be caused by shock/strut assembly and sweating around the seal.

Figure 3) Not a leaking shock/strut

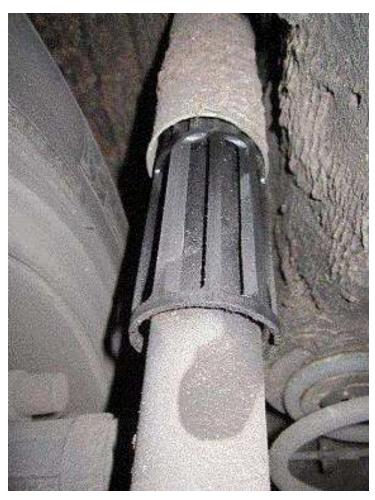
Figure 4) Not a leaking shock/strut
