# Service Bulletin

Bulletin No.: 15-06-01-002N

Subject: Engine Misfire/Tick Noise, Malfunction Indicator Lamp (MIL) Illuminated - DTC

Models: 2015-2020 Cadillac Escalade

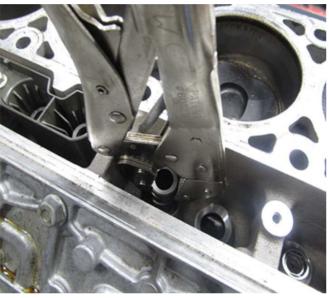
4250109

There are two approved processes for removing the lifter when stuck in the bore.

1. Use vice grips with a slide hammer.

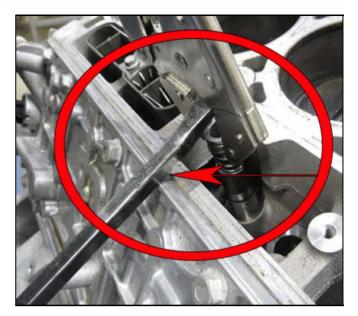
4921302

**Note:** Be sure **NOT** to pry on the sealing surface of the block, as shown in the illustration above.

2. Use vice grips with a small pry bar.
