Service Bulletin

Bulletin No.: 19-NA-220

Subject: Loss of Propulsion, Malfunction Indicator Lamp (MIL) Illuminated - DTC P0A3F and/or P1B03 Set

Brand:	Model:	Model Year:		VIN:		Engine:	Transmission:
		from	to	from	to		
Chevrolet	Bolt EV	2017	2023	—	—	—	—
	Bolt EUV	2022		—	—	—	—

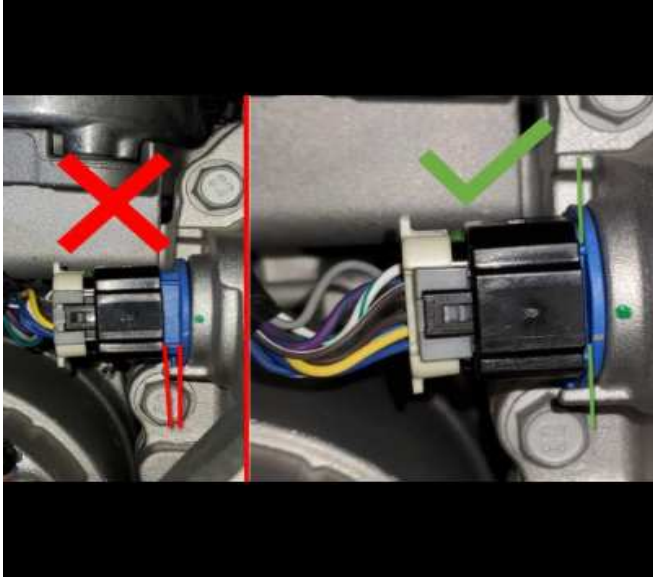
5518453

Ensure that the connector is fully seated.

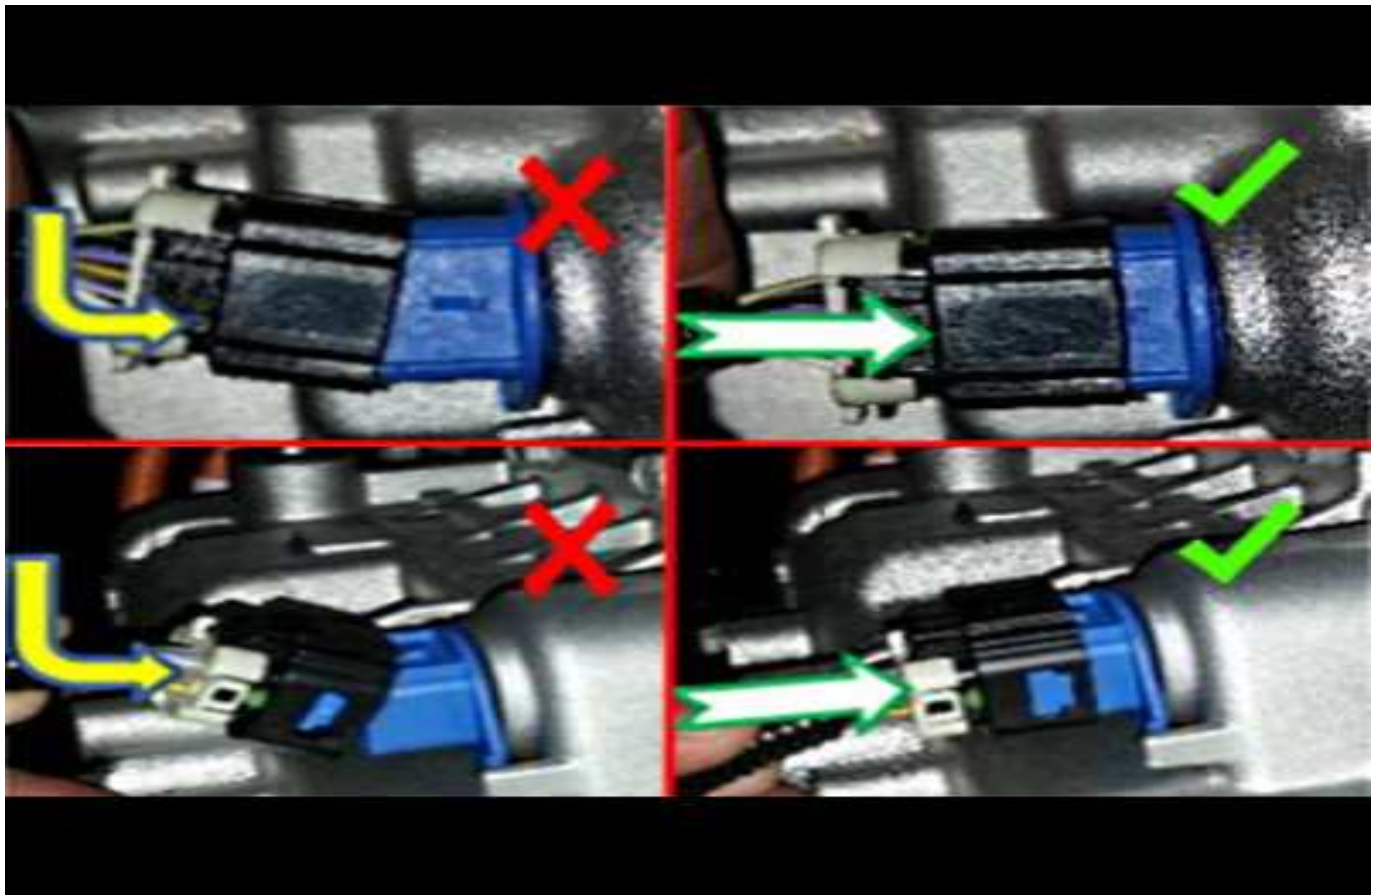
5409322

Showing both proper and improper alignment of the X2 connector.

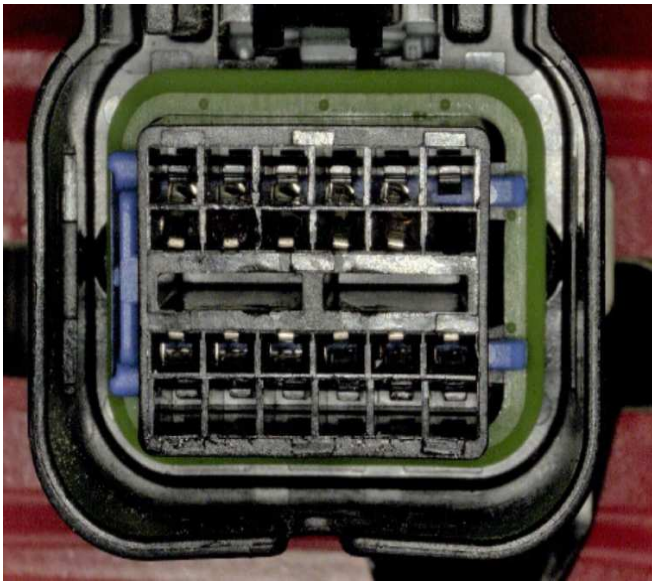
5409321

Example case of damaged terminals. Terminals do not need to have visible damage to set DTCs P0A3F and P1B03.

Correction	<p>Replace the engine wiring harness.</p> <p>Due to the sensitivity of resolver (motor position sensor) circuits, replacing the connector with a terminated lead is not permitted per SI document ID 4583435. These diagnostic codes result in a loss of propulsion event on the vehicle.</p> <p>Exercise care when connecting the new harness to X2 on the transmission by aligning the connector bodies and not attempt to install at an angle.</p>
