# Service Bulletin

Bulletin No.: 21-NA-142

**Subject: Front Brake Grind/Groan Noise After Sitting Overnight**

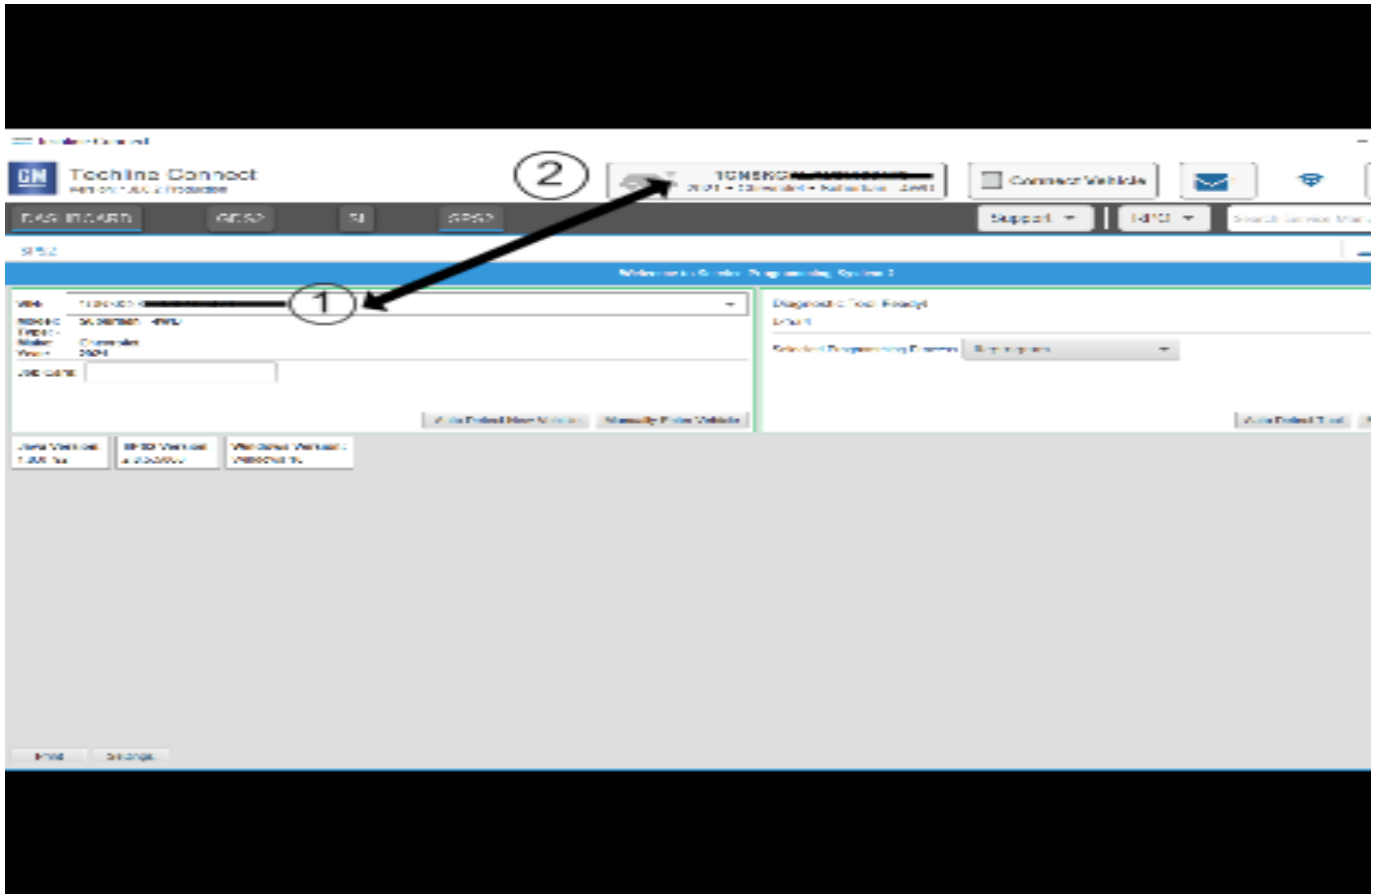
5743643

**Caution:** Be sure the VIN selected in the drop down menu (1) is the same as the vehicle connected (2) before beginning programming.

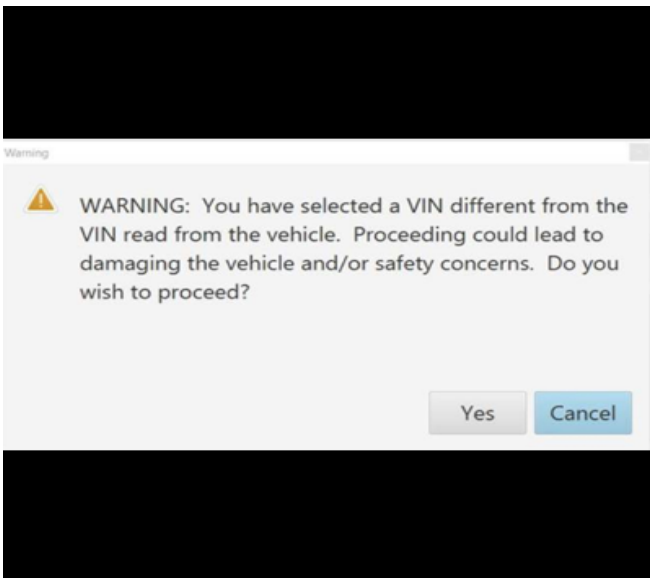
5877000

**Important:** If the vehicle VIN DOES NOT match, the message below will be shown

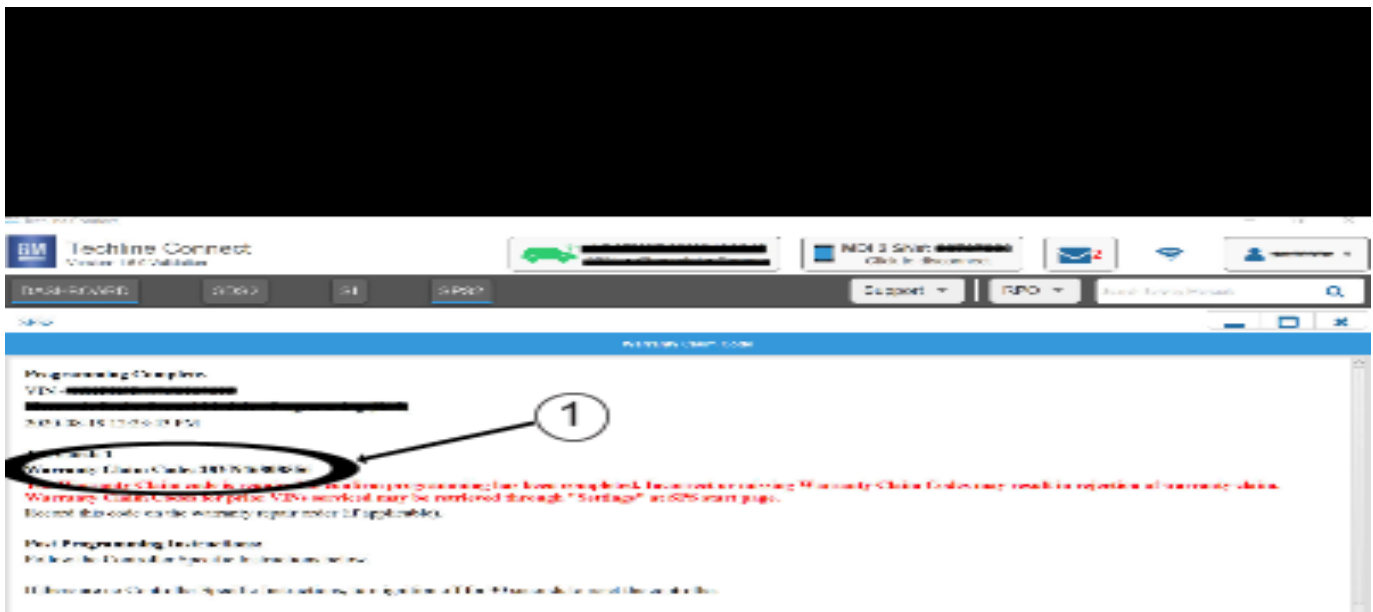
5644478

**Note:** The screenshot above is an example of module programming and may not be indicative of the specific module that is being programmed. Module selection and VIN information have been blacked out.

**Important:** To avoid warranty transaction rejections, you MUST record the warranty claim code provided on the Warranty Claim Code (WCC) screen shown above on the job card. Refer to callout 1 above for the location of the WCC on the screen.

2. Record SPS Warranty Claim Code on job card for warranty transaction submission.
