Service Bulletin

Bulletin No.: 22-NA-008

Subject: Malfunction Indicator Lamp (MIL) Illuminated, Reduced Engine Power Message on Drivers Information Center (DIC) - DTCs U060F, U1346, P0101, P0102, P1101 and/or P14B6 Set

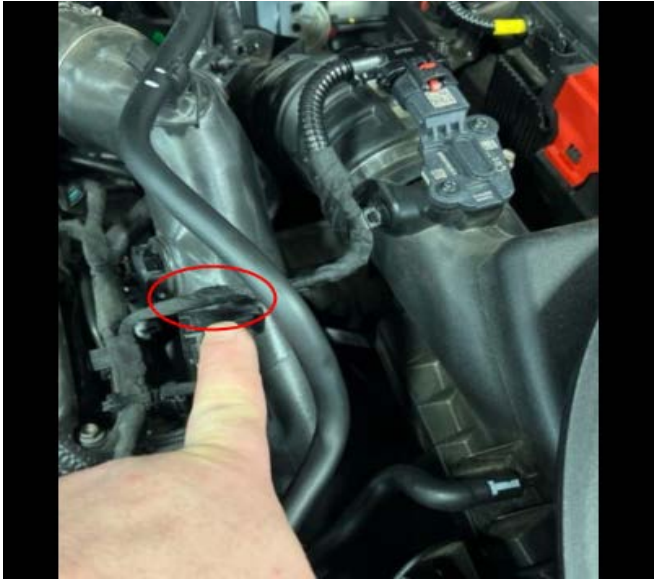
Involved Region or Country	North America
Condition	<p>Some customers may comment on one or more of the following conditions:</p> <ul style="list-style-type: none"> • MIL illuminated • Reduced Power displayed on DIC <p>Some technicians may find one or more of the following DTCs set:</p> <ul style="list-style-type: none"> • U060F • U1346 • P0101 • P0102 • P1101 • P14B6
Cause	<p>This condition may be caused by a possible broken wire in the harness in circuits 492 of the multifunction sensor.</p> <div style="text-align: center;">

</div> <p style="text-align: right;">5956039</p> <p>– The zip tie at the retainer may be pulled too tight and when the harness flexes on accelerations the wire can break at the zip tie.</p>

<p>Correction</p>	<p>Inspect the 2nd retainer back from the MAF sensor with the engine running. If the zip tie is too tight the wire may break at the zip tie during acceleration:</p> <ul style="list-style-type: none"> ⇒ Wiggle or pull on the harness to induce and identify a break inside the harness. ⇒ Repair circuit using published wire to wire repair for the MULTIFUNCTION INTAKE AIR SENSOR (MAF SENSOR). ⇒ Rewrap the wiring harness as required.
