# RSB-56-23-001-1: Front Door Fixed Glass Molding Separation

<b>Document Type</b>	Technical Service Bulletin
<b>Date</b>	February 16, 2023
<b>Affected Region(s)</b>	USA
<b>Affected Model(s)</b>	R1T, R1S
<b>Model Year(s)</b>	2022
<b>Approximate Build Dates</b>	March 2022 - September 2022

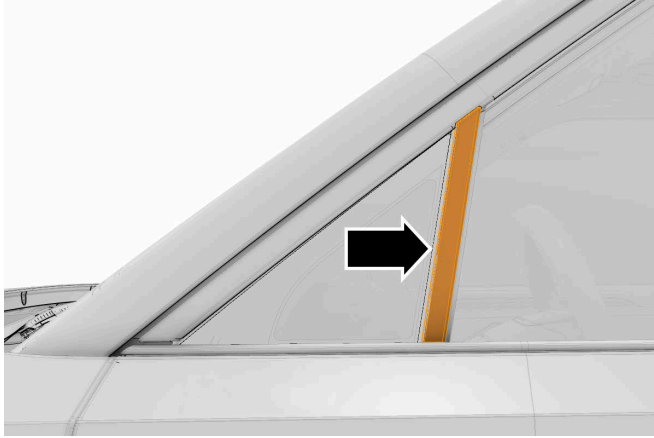
On both sides: Inspect:

- If either the LH or RH component is loose: Continue to the [Procedure](#) section.
- If neither component is loose: This bulletin is not applicable. Discontinue this procedure.

1. On both sides: Replace: Glass, Door, Fixed, Front (refer to service manual procedure 561015010).
2. Reinstall all components that were removed for access and replace all non-reusable components. Refer to the service manual procedures referenced in this document for additional component reusability information and torque specifications.
