RCA-30-23-001-1: Update Battery Management System Firmware

Document Type	Customer Satisfaction Campaign Bulletin
Date	February 16, 2023
Affected Region(s)	USA
Affected Model(s)	R1T
Model Year(s)	2022
Approximate Build Dates

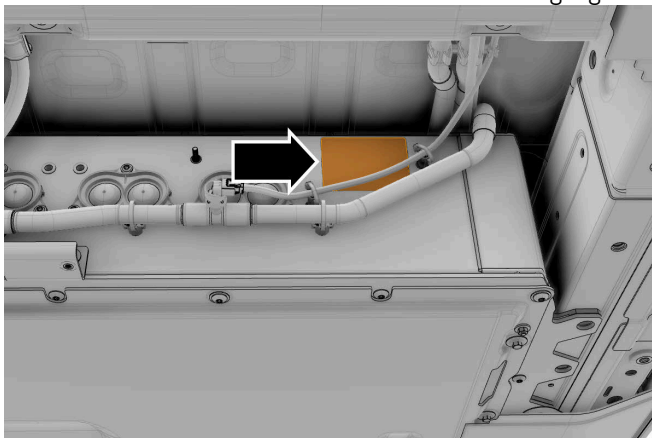
1. Remove: Duct, HVAC, Intake, Upper, Front (refer to service manual procedure 266441010).
2. Connect float chargers to the 12V batteries.
3. Remove: Panel, Underbody, Rear Subframe (refer to service manual procedure 606516010).
4. Note the serial number near the bottom of the highlighted label.

Note: Shown with components removed for clarity.

5. Escalate for diagnostic assistance.
6. Reinstall all components that were removed for access and replace all non-reusable components. Refer to the service manual procedures referenced in this document for additional component reusability information and torque specifications.
