<b>HYUNDAI</b> <b>Technical Service Bulletin</b>	GROUP <b>FUEL SYSTEM</b>	NUMBER <b>23-FL-001H</b>
	DATE <b>FEBRUARY 2023</b>	MODEL(S) <b>APPLICABLE VEHICLES BELOW</b>
<b>SUBJECT:</b> ECU SOFTWARE UPDATE (DTC P1441/P1A77/P00B7/P2118/P0401/P0236/P0299)

**This TSB supersedes 22-FL-003H to remove the Tucson Hybrid/Plug-in.**

This bulletin provides information related to the Engine Control Module (ECM) software update for Santa Fe Hybrid (TM HEV) / Santa Fe Plug-In Hybrid (TM PHEV) vehicles to revise the following DTC logic:

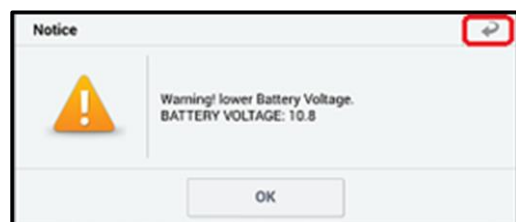
**GDS Vehicle Battery Voltage Warning:**

If voltage is below 12 volts as per the GDS warning, then select **Back** and run the engine at least 15 minutes to reach an adequate battery state of charge to prevent ECU Update failure. Cycle the ignition **OFF/ON** before retrying ECU update again.
