Technical Service Bulletin

| GROUP CAMPAIGN | NUMBER 23-01-017H |
| DATE MARCH 2023 | MODEL(S) Ioniq 5 Electric (NE1) |

SUBJECT: IONIQ 5 EV BATTERY CONDITIONING TO OPTIMIZE COLD DC CHARGING (SERVICE CAMPAIGN T9Q)

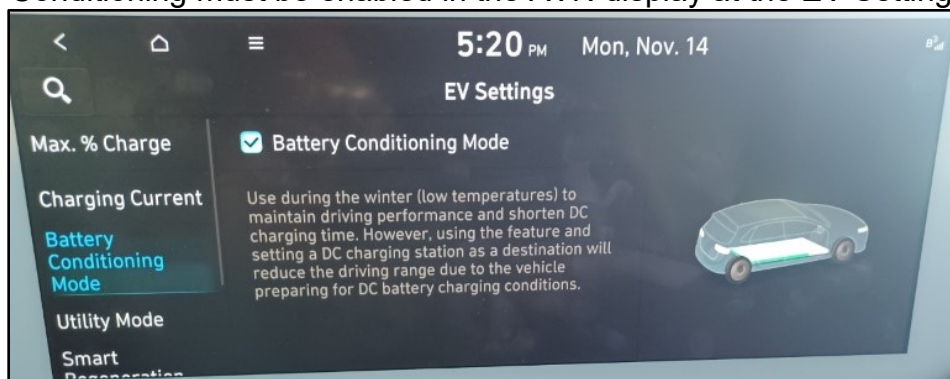
1. The Battery Conditioning must be enabled in the AVN display at the EV Settings Screen:

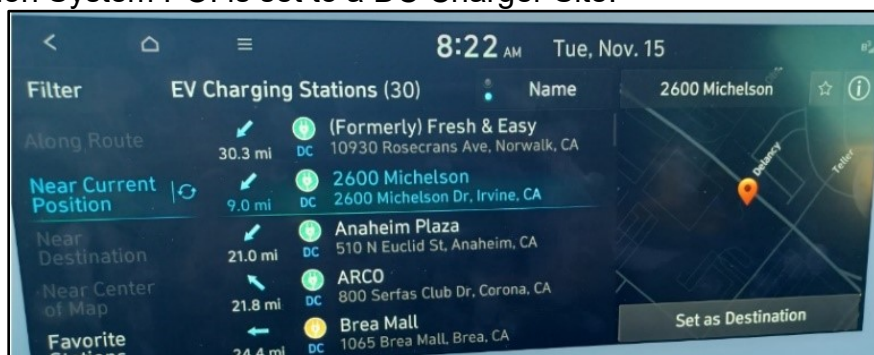
2. The Navigation System POI is set to a DC Charger Site.

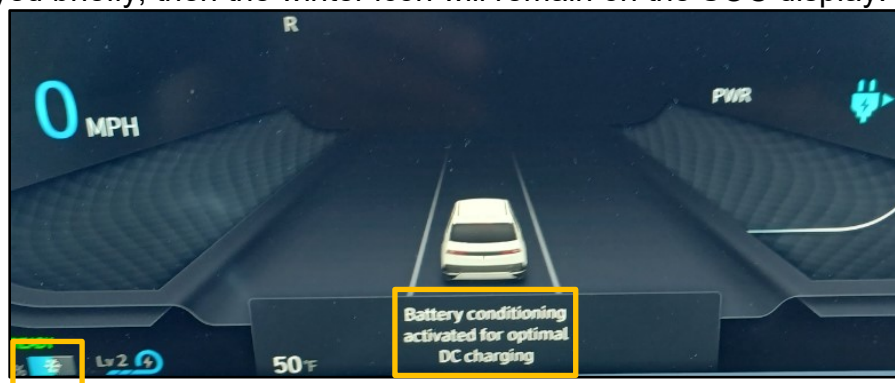
3. When the Battery Module Temperature is below 68°F (20°C), then the Battery Conditioning will activate after 1 - 2 min of heating system checks and preparation. The following splash screen will be displayed briefly, then the winter icon will remain on the SOC display.

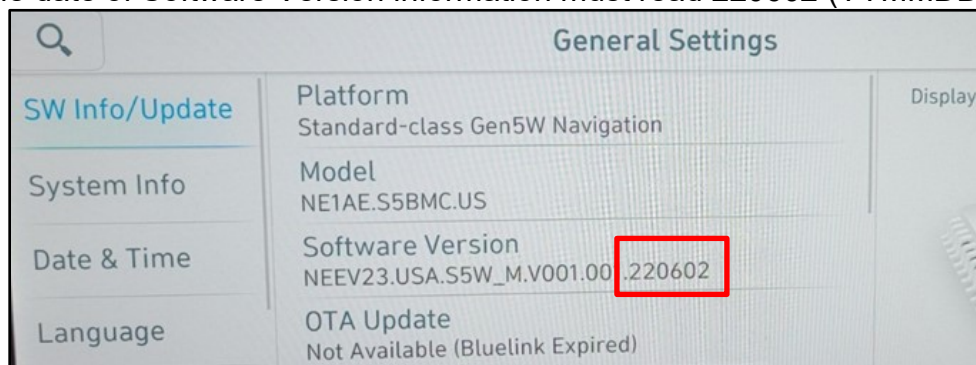
Certain IONIQ 5 vehicles with software versions older than October 2021 (211001) must be updated.

- Press the SETUP button on the trim below the display screen.
- Press General Settings in the menu displayed on the screen (if not displayed you may need to scroll down)
 - a. The date of Software Version information must read 220602 (YYMMDD)
