SERVICE BULLETIN

NUMBER: 15-236-18R

SUBJECT: Reprogramming File Availability for Optimization of Harman Gen 3.1 and Gen 3.1α Audio and Navigation Head Units

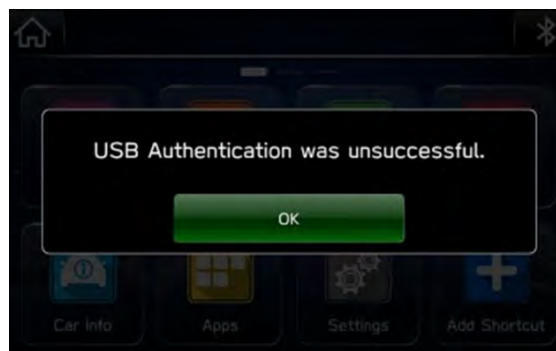
NOTE: If an attempt is made to install the wrong “grade” file into the wrong grade head unit (EXAMPLE: “Base” update file into a “Base Plus or Mid” or “High” head unit), the USB Authentication error screen below will be displayed:

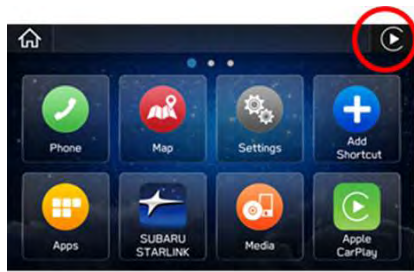
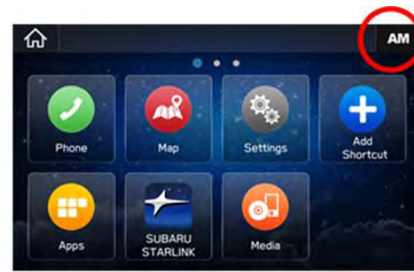
On Ver. 6.0 and before:

Music playing via iPhone in CarPlay.

After disconnecting, the music source changes to Radio automatically.

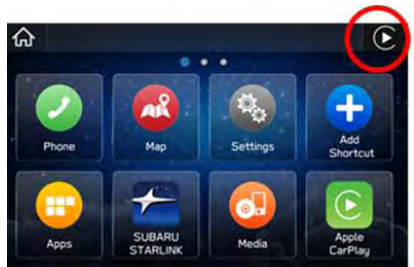
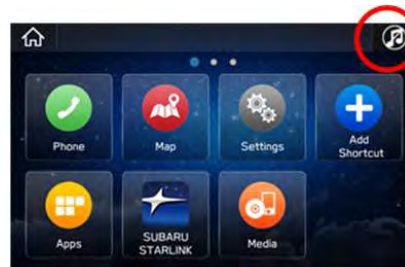
Music playing via iPhone in CarPlay.

After disconnecting, no music source is selected automatically.

If a source of music other than CarPlay has been playing when the iPhone is disconnected, the music source remains same (it is not turned off.)

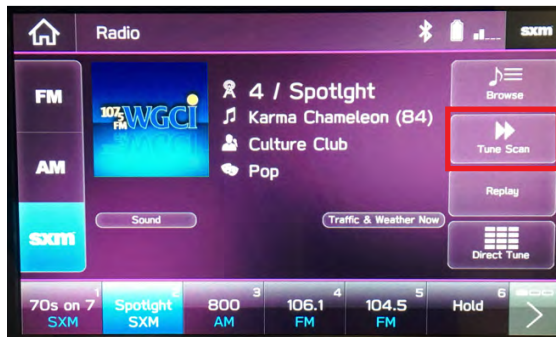
<Scan> previously displayed on SXM screen was changed to <Tune Scan> (a.k.a. SEEK).

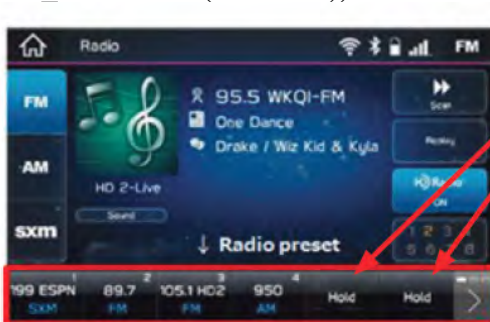
1) Station presets are lost. Touch buttons read “Hold”. (Applicable for software versions Rel_4.18.25.50 (or before)). Included in software version Rel_U1.18.38.50.
