## **SERVICE BULLETIN**

APPLICABILITY: 2019-22MY Ascent NUMBER: 07-219-23

**SUBJECT:** Genuine Alternative Battery Replacement

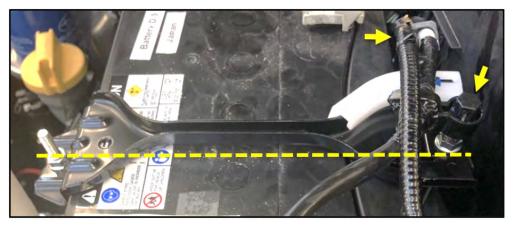
**NOTE:** Confirm the battery holder is center mounted with the battery cables secured and routed correctly.
