PRODUCT CAMPAIGN BULLETIN

APPLICABILITY: 2019-2022MY Ascent

NUMBER: WRL-22R

SUBJECT: PTC Heater Ground Bolt

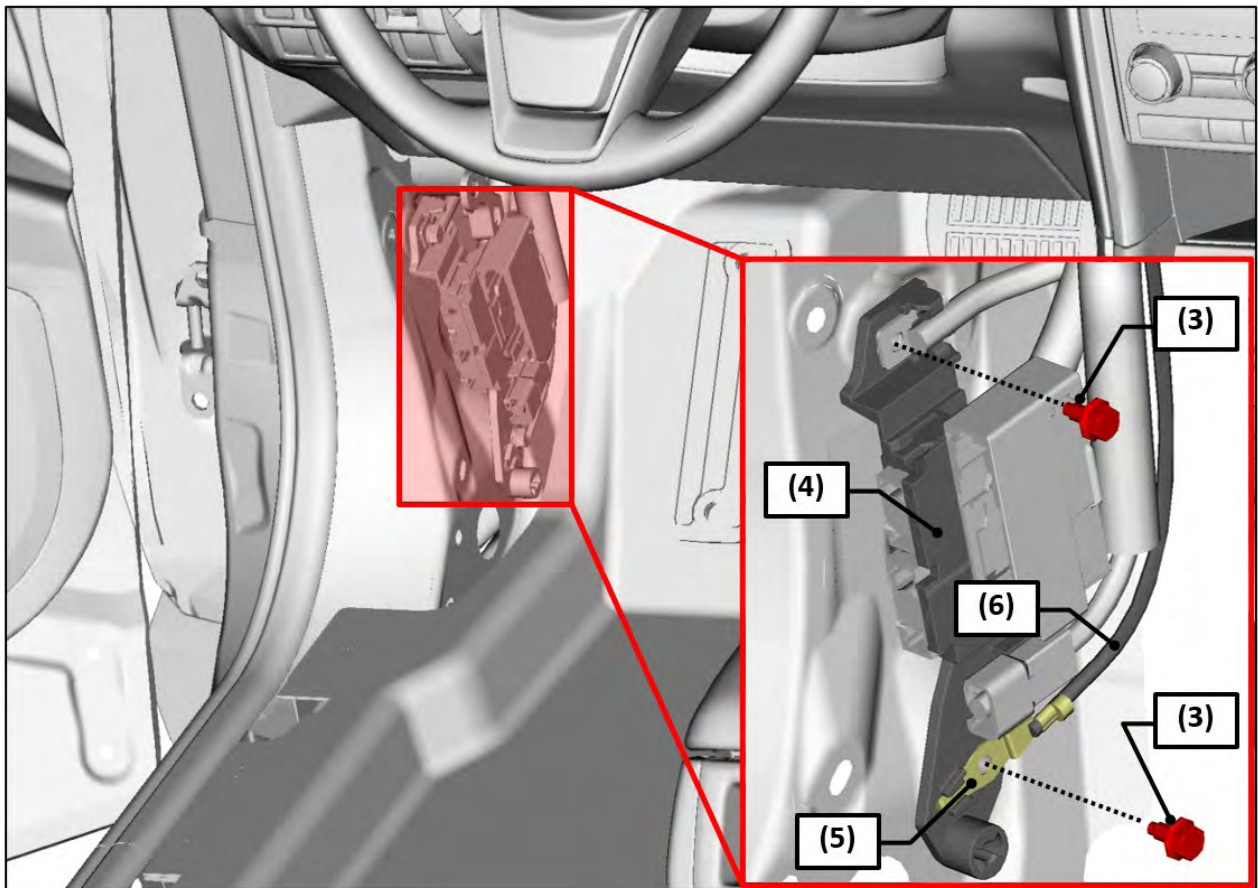
Diagram 1

(3) Ground bolts

Tightening Torque: 13 N·m

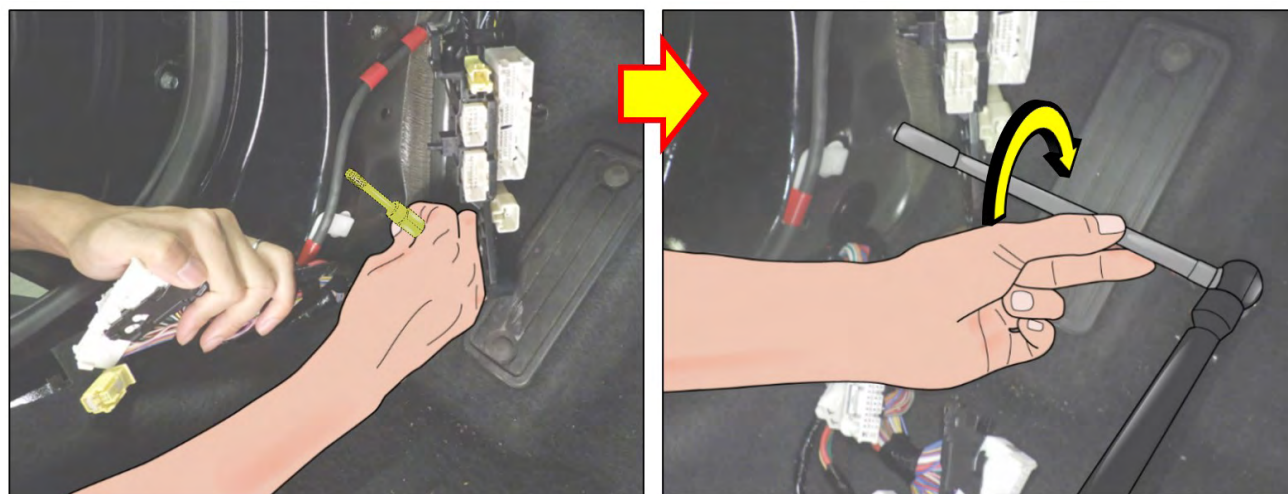
STEP 8: Thread the thread chaser into both of the ground bolt holes. Use a torque wrench to turn the thread chaser. If the turning torque is 7Nm or higher, clean the threads with a tap and recheck the turning torque. Once the turning torque is less than 7Nm, continue to the next STEP.

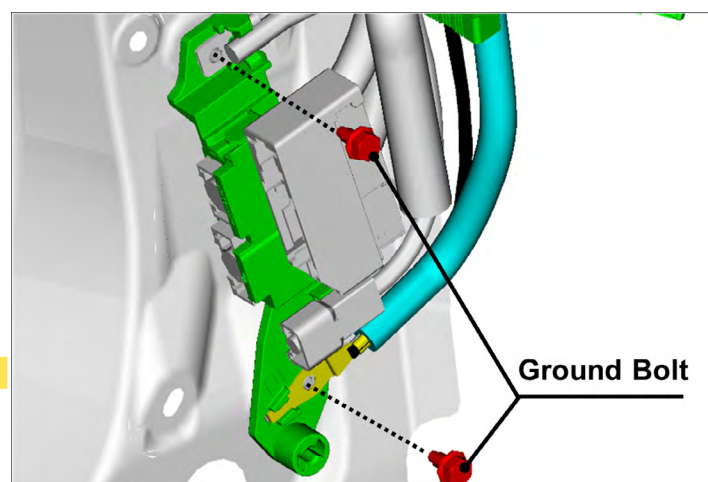
STEP 24: Install the new ground bolts and torque to 13Nm.

IMPORTANT: CONFIRM bolts are torqued to 13Nm. If a torque of 13Nm cannot be achieved, a QMR must be submitted. Contact Techline for further instruction.
