Articles Contained in this Issue

15 CP 1.0/1.5 Software Version Verification

07 CAN Communication Diagnosis – Where To Start?

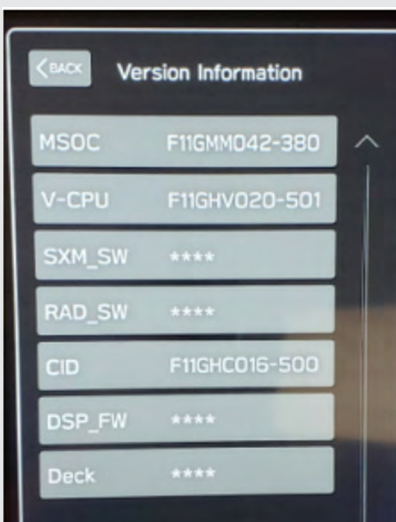
When confirming CP 1.0/1.5 system software version information, it is critical to allow the unit to finish the boot-up process before accessing the version information screen. Failure to allow the process to complete could result in missing version information or asterisk symbols (****) as shown below. A good practice would be to **wait a minimum of 3 minutes after the boot-up process** begins at key on for this information to load properly.

However, this should not be confused with no “RAD_SW” version and “DSP_FW” version displayed or showing asterisk symbols (****) AFTER waiting for the system to completely boot-up. That would be a sign of a failed software update. For more details see SubaruNet announcement [“Recall WRH-20 / WRI-20 Denso Gen 4 CP1 software update. Critical points to avoiding unnecessary hardware replacement”](#) posted January 5, 2021. **Note: “Deck” version as asterisk symbols (****) is normal when a CD Player is not installed.**

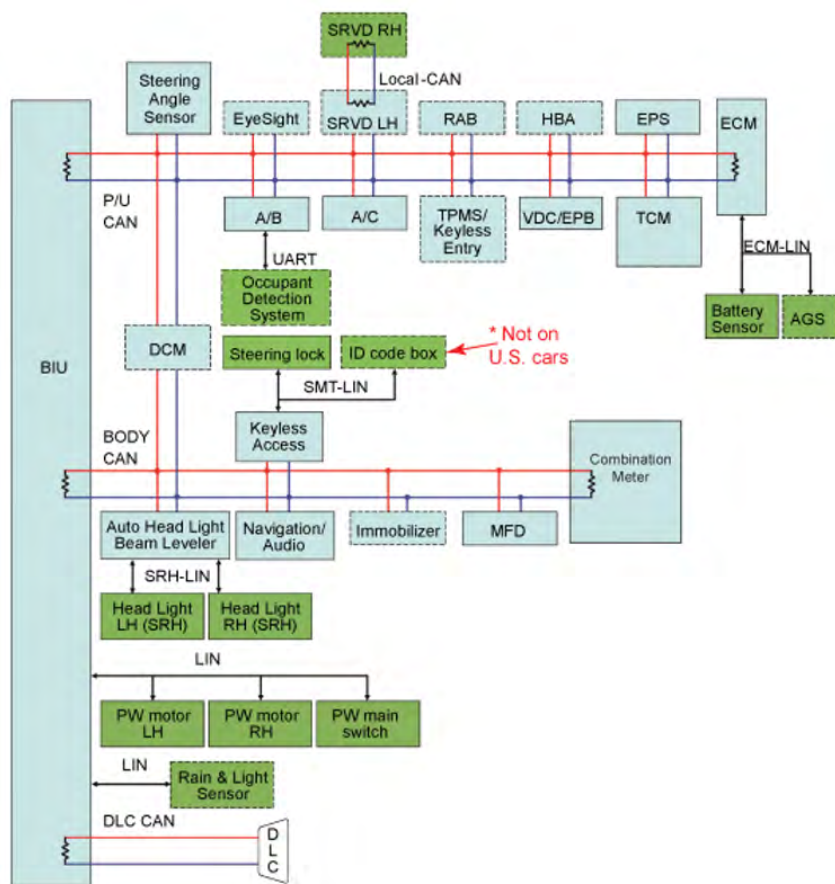
Refer to the “CAN communication circuit check” found in the service manual. The all-DTC scan will tell us which modules cannot communicate with each other. Then inspect the circuit between those modules. If every module on a given bus is down, the harness could be shorted to power/ground. If the harness is ok, the issue could be a faulty module pulling the bus down. Disconnecting each module until communication with the other modules is restored is a quick check.

If communication to only one module is down, verify that module has power and ground supply and a good connection to the CAN circuit. If all tests ok, the module itself may need replacement.

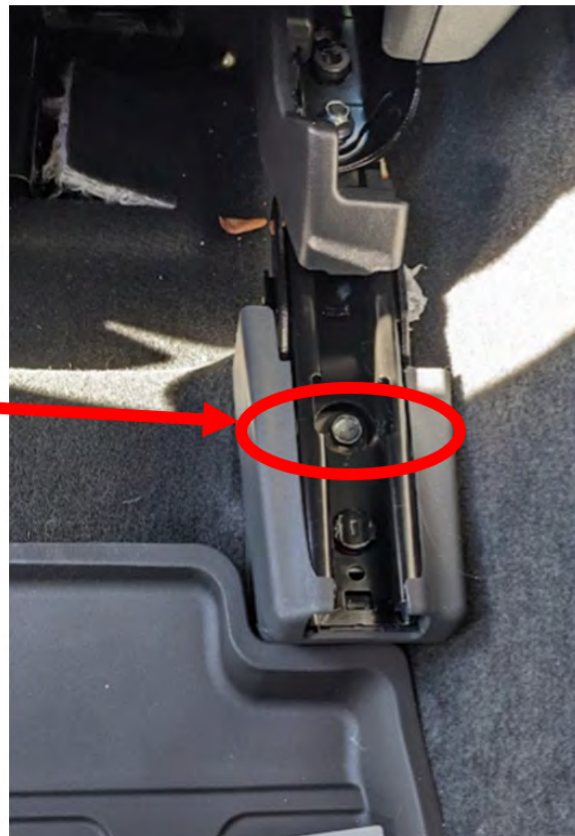
It has been found that on MY20+ Legacy/Outback, the bolts to remove the seat can only be accessed with the seat position adjusted to a specific position. In a scenario where the slide motor fails and this position cannot be achieved, there is a manual adjustment that can be made to expose the bolts to remove the seat. Further information can be found by viewing QMR [TS-215498](#).

The rear in-board mounting bolt is now vertical as opposed to previous generations that were installed at an angle. As a result the seat needs to be in a forward position to access.

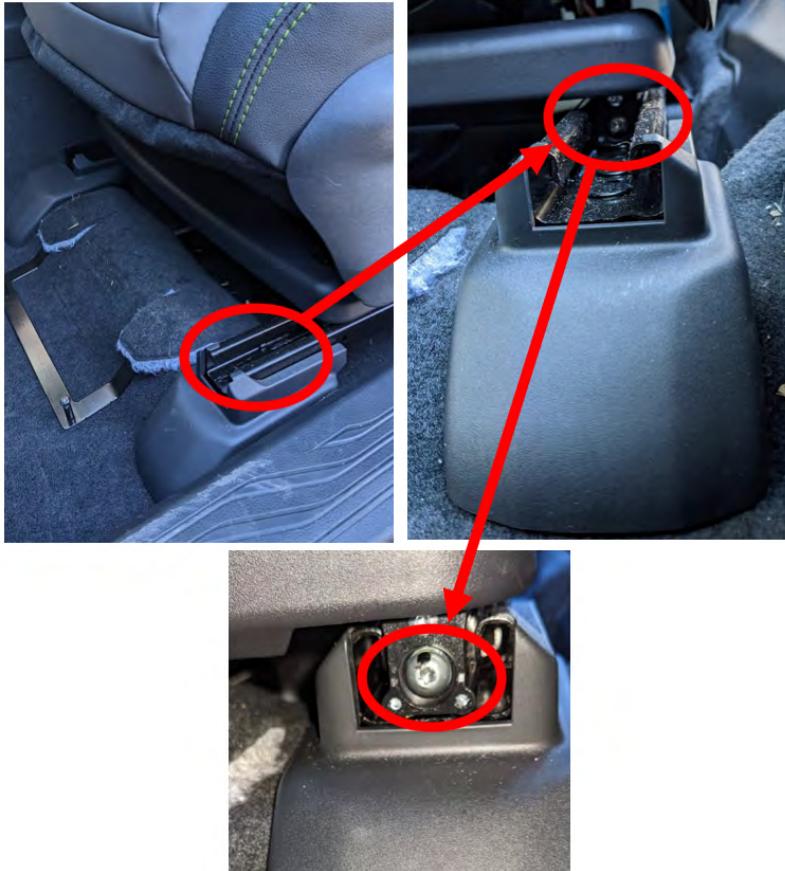
If the slide motor is not able to be used to move the seat in the forward position, there is a T20 TORX head bolt at the front of the seat rail/frame that can be used to move the seat manually forward and back. The T20 Torx bolt for adjustment is on both the left and right hand seat rails, one bolt will move the seat forward and the opposite bolt will move the seat backward.

NOTE: This function is available on both the passenger and driver side front seats with the power seat option.

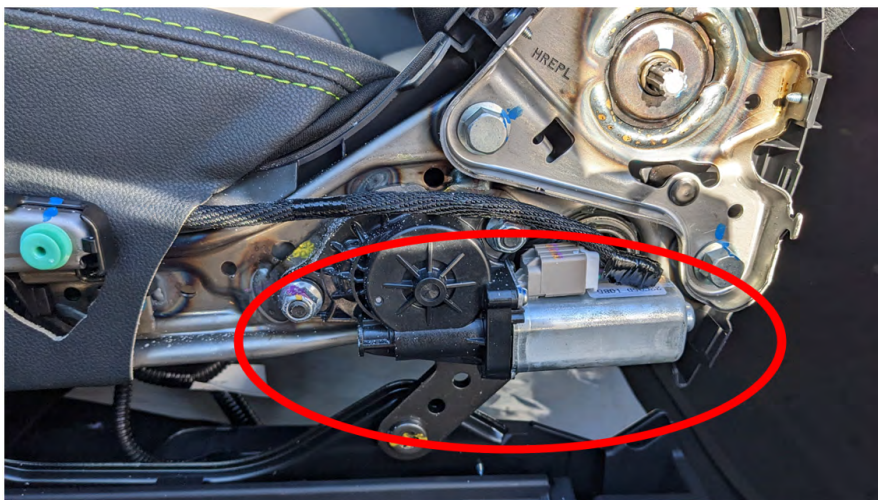
If the motor to raise and lower the seat bottom fails, there is no manual 'adjustment screw' available. The technician will need to remove the seat side cover and physically unbolt/remove the motor.

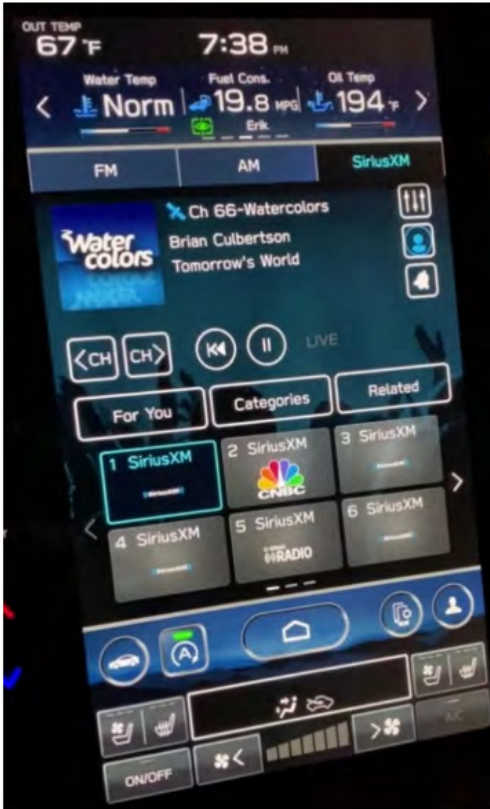
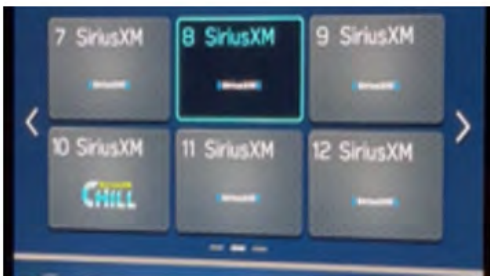
On all vehicles equipped with a CP 1.5 head unit ('23 Legacy/ Outback/Ascent) the SXM channels presets will not show the specific SXM channel logos when the vehicle is new. **This is a normal condition.**

This condition is due to the head unit not receiving any SXM signal. While the vehicle is in transport to the retailer the back-up fuse is not installed.

The head unit does not turn on or receive power until the back-up fuse is installed during the PDI procedure.

It will take 4-6 hours of the vehicle receiving SXM signal (key on, engine running) for all the SXM channel logos to appear. Do not replace any parts for this concern.

If this concern is present **after** 6 hours of the vehicle being operated in a known good SXM signal area, please refer to **TSB 15-304-22**. Collect a data log, all other requested information and submit an Infotainment case using **Techshare**.
