SERVICE INFORMATION

APPLICABILITY: All Models with STARLINK Telematics System **NUMBER:** 15-195-16R
SUBJECT: Servicing and Claim Submission Requirements for STARLINK Diagnosis and Repair Involving the Data Communication Module (DCM) **DATE:** 04/28/20
REVISED: 02/27/23

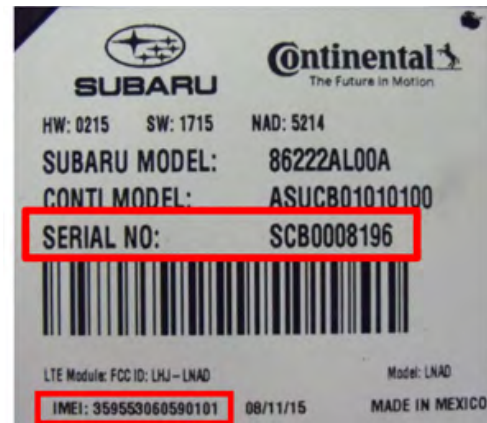
5) Effective Immediately, all claims for DCM replacement **MUST** include the 10-digit DCM Serial Number of the installed (new) DCM. This number is found on the DCM label shown here and **MUST** be entered in the Miscellaneous Detail field of the claim entry.
