Subject: N222391310 - Service Update  
Torque Converter Housing Access Hole Cover Not Installed

Models: 2023 Chevrolet Silverado 2500HD/3500HD  
2023 GMC Sierra 2500HD/3500HD  
Equipped with TRANSMISSION-AUTO 10 SPD, 10L1000, GRX, GEN  
1, VAR 1 (RPO MGM)

## N222391310 Torque Converter Housing Access Hole Cover Not Installed

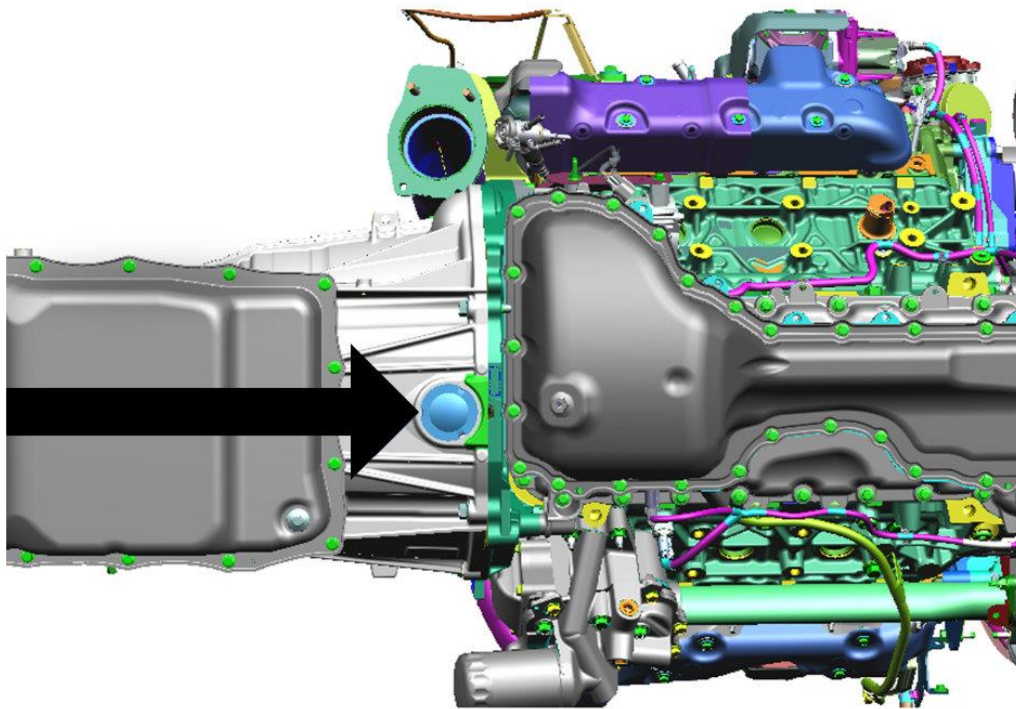
6281257

<b>Condition</b>	Certain 2023 model year Chevrolet Silverado 2500HD/3500HD and GMC Sierra 2500HD/3500HD vehicles, may have a condition in which the torque converter housing access hole cover was not installed.
<b>Correction</b>	Dealers are to install the torque converter housing access hole cover.

2. Snap the torque converter housing access hole cover into the inspection port located on the underside of the bellhousing, indicated by the arrow above.
3. Lower the vehicle. Refer to *Lifting and Jacking the Vehicle* in SI.
