Technical product information

Topic	Wind noise from the lower A pillar (Rain deflector area)
Market area	Russische Föderation (5RU),Australia E04 Bentley rest Asia and Australia (6E04),China 796 VW Import Comp. Ltd (Vico), Beijing (6796),Germany E02 Bentley rest Europe (6E02),Japan E03 Bentley Japan (6E03),Korea, (South) E08 Bentley South Korea (6E08),United Arab Emirates E06 Bentley Middle East and Africa (6E06),United Kingdom E01 Bentley UK (6E01),United States E05 Bentley USA and rest America (6E05)
Brand	Bentley
Transaction No.	2069014/1
Level	EH
Status	Approval
Release date

- Wind noise from the lower A pillar (Rain deflector area)

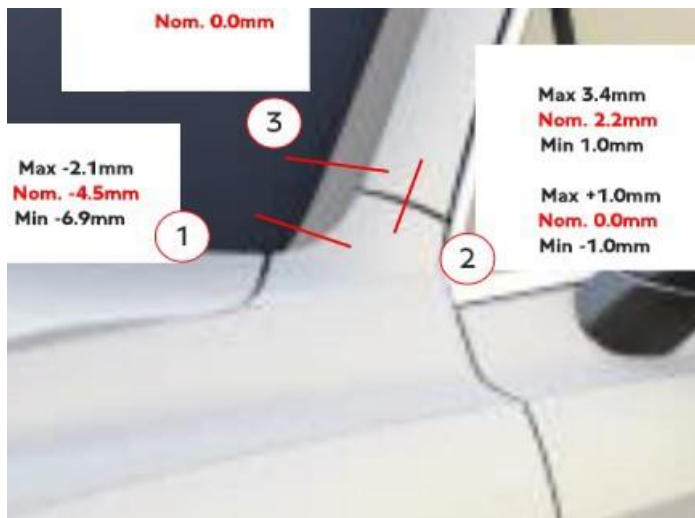
Profile deviation between the front wing and front wing mounting bracket can contribute to wind noise from the lower A pillar (Rain deflector area)

IMPORTANT: Before proceeding the operative must check to confirm the gap and profile of the front wing in relation to the A-post as shown in Figure 1 points 1 -2 - 3

HINT: Ensure the bonnet is fully closed prior to checking the gaps and profiles

- In the event the issue is as described and the tolerances are not as shown within Figure 1, the operative should refer to the instructions within the Measure section

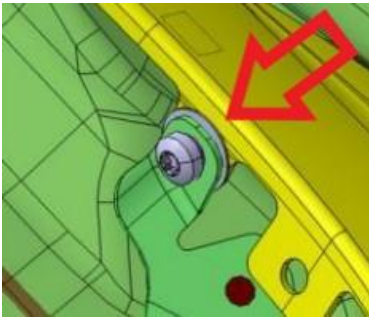
The washer(s) act as spacers to correct the twist within the front wing mounting bracket

In the event the issue is as described fit 0.5mm nylon Washer(s) between the front wing and front wing mounting bracket (maximum of x2 washers)

3) Referring to Figure 3 - Fit x1 nylon washer at the location shown between the front wing and front wing mounting bracket

- Refit the upper fixing (6 Nm)
