# Technical Service Bulletin

# Mazda North American Operations Irvine, CA 92618-2922

Subject:	
COOLANT LEAKS AT CYLINDER HEAD	Bulletin No.: 01-002/23
	Last Issued : 02/10/2023

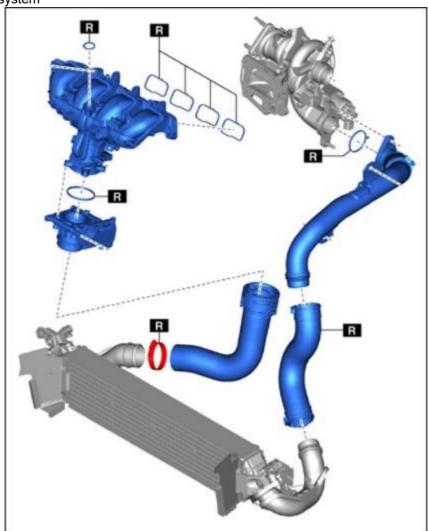
· Gaskets for intake-air system

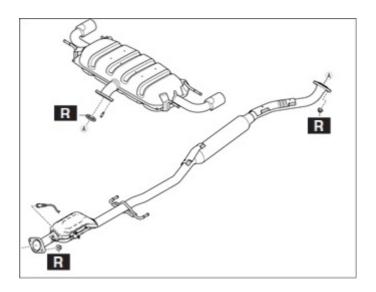
· Gasket and nuts for TWC

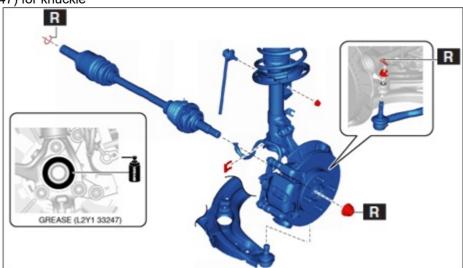
- · Snap pin for Tie-rod end
- · Lock nut for Driveshaft
- · Clip for Drive shaft (LH)
- Grease (L2Y1-33-247) for knuckle

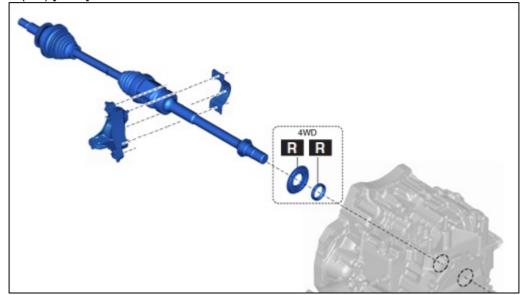
• Transfer oil seals (RH) [4WD]

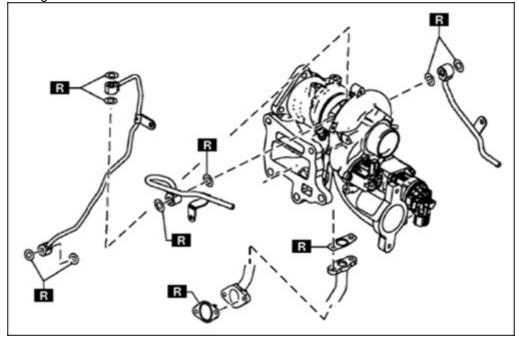
· Gaskets for turbocharger

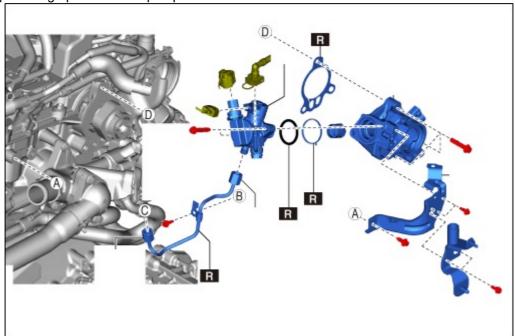
· Gaskets and pipe for high pressure fuel pump

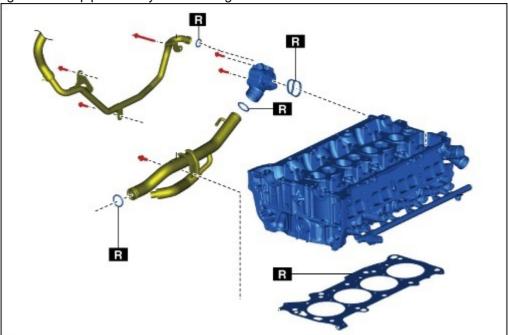
· Gasket and O-rings for water pipes and cylinder head gasket
