Technical Service Bulletin

Mazda North American Operations
Irvine, CA 92618-2922

Subject: FRONT AND REAR BRAKE NOISE	Bulletin No.: 04-001/23
	Last Issued : 02/13/2023

2013-2023 CX-5

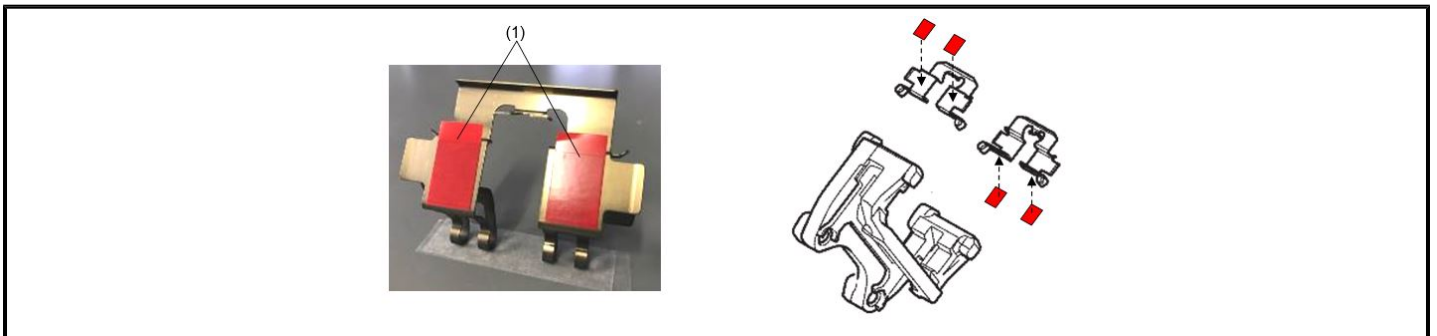
Rear Brake Noise Symptom 1: Some vehicles may exhibit a squeak noise from the rear brakes while braking lightly and occurs more frequently when driving at slow speeds. The noise is caused by poor contact between the guide plate and the mounting support. To eliminate this concern, the material of the pads has been changed to copper-free and the specification of the shims has been changed to a coated spring with tape.

- Verify if the tape is installed to both guide plates (some kits do not have the tape installed and is packaged separately).
- If the tape is not applied to the guide plates, peel off the red release film (1) and the dual adhesive tape (2) from the release paper (3) and apply the dual adhesive tape to the contact surfaces of the guide plates as shown below.
