# Technical Service Bulletin

<b>Subject:</b>  ABNORMAL NOISE WHEN OPENING POWER LIFTGATE	<b>Bulletin No.:</b> 09-009/23
	<b>Last Issued :</b> 02/07/2023

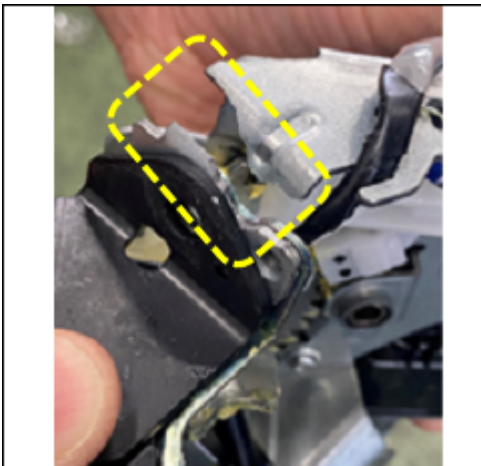
Some customers may report hearing an unusual noise coming from the power liftgate (PLG) when it is unlatching to open or latching closed. This is caused by an internal fault in the liftgate latch and/or loose bolts holding the latch to the liftgate. To eliminate this concern, the internal structure of the latch and surface treatment of the bolts have been modified.

The latch bracket is damaged

1. Verify the customer concern.
2. Replace the latch and bolts with the improved parts listed in the parts section following the instructions in MGSS:
  - **CX-30: LIFTGATE LATCH AND LOCK ACTUATOR REMOVAL/INSTALLATION**
  - **CX-50: LIFTGATE LATCH AND LOCK ACTUATOR REMOVAL/INSTALLATION**
3. Verify the repair by confirming the noise has been eliminated.

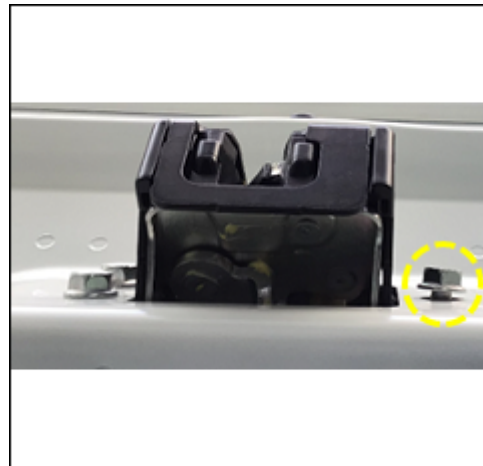
The bolt is loose
