# Technical Service Bulletin

POWER FOLDING DOOR MIRROR(S) DO NOT COMPLETELY FOLD IN AND/OR OUT WHEN NOT FROZEN IN PLACE BY ICE OR SNOW

Bulletin No.: 09-011/23

Last Issued: 02/09/2023

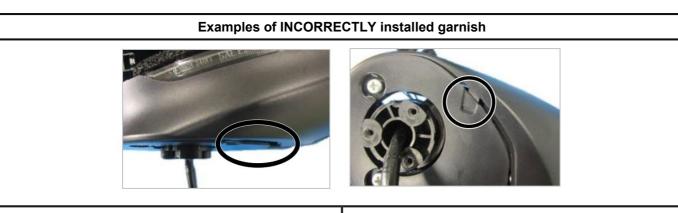
**NOTE:** Install the lower outer garnish in the correct position.

NO GOOD NO GOOD

d. Install the lower outer mirror garnish engaging the hook (1) and tighten the screw (2).
