Service Bulletin

Bulletin No.: 22-NA-041

Subject: Air Conditioning is Not Blowing Cold Air

Brand:	Model:	Model Year:		VIN:		Engine:	Transmission:
		from	to	from	to		
Chevrolet	Corvette	2020	2022	—	—	—	—

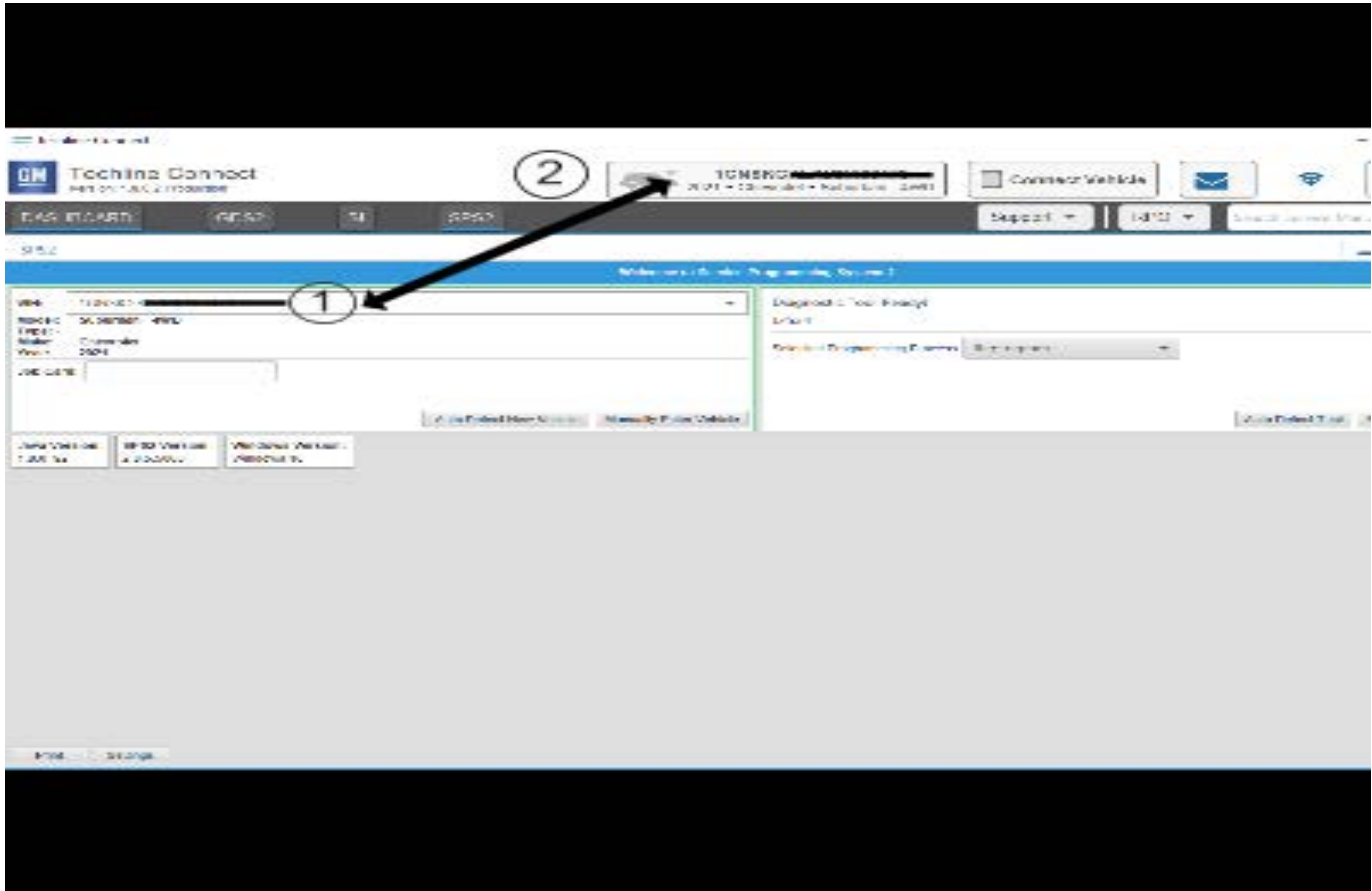
5743643

Caution: Be sure the VIN selected in the drop down menu (1) is the same as the vehicle connected (2) before beginning programming.

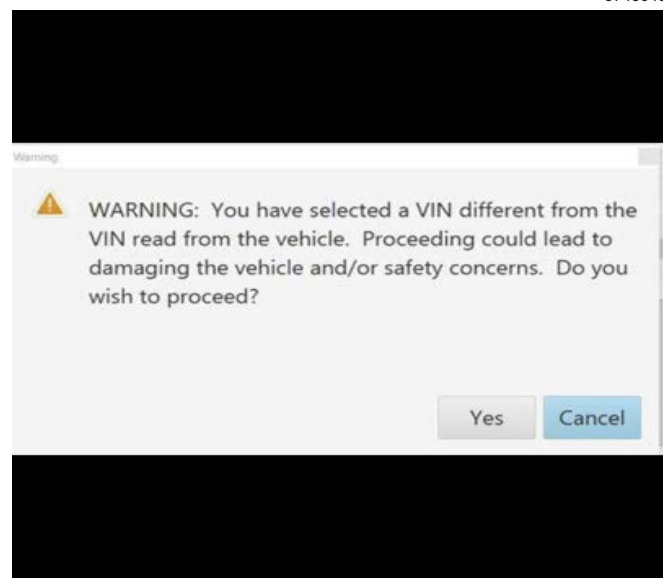
5877000

Important: If the vehicle VIN DOES NOT match, the message below will be shown.

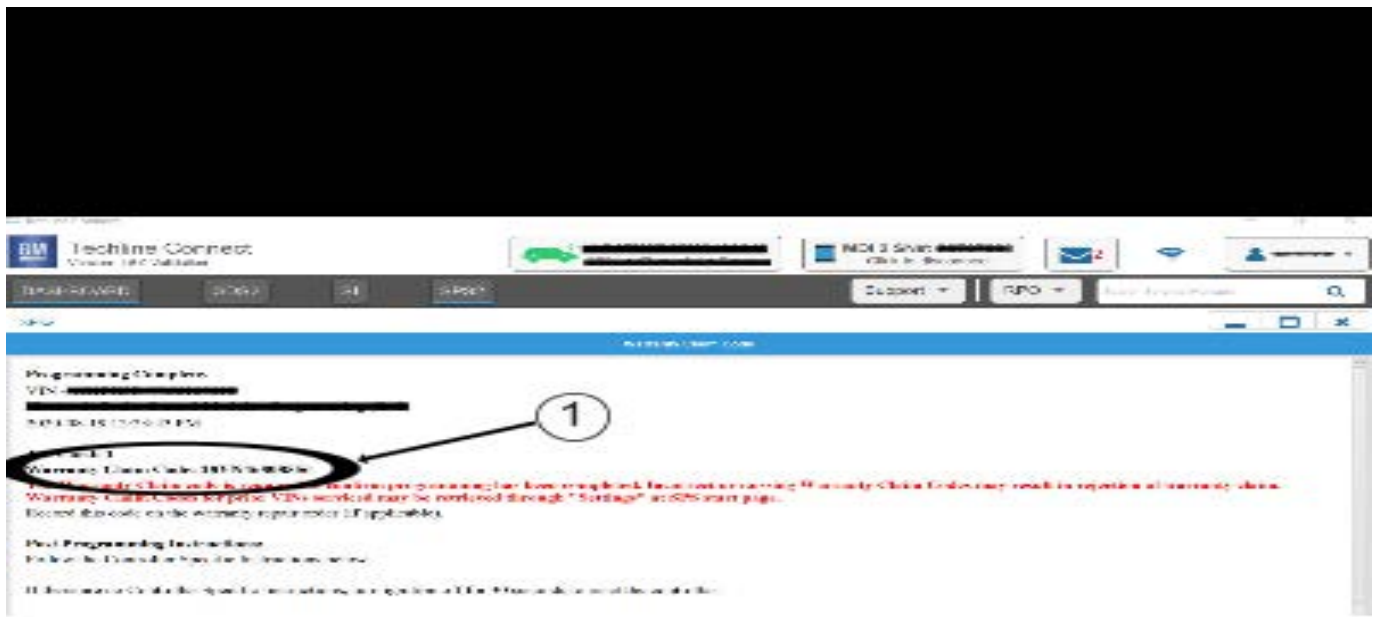
5644478

Important: To avoid warranty transaction rejections, you **MUST** record the warranty claim code provided on the Warranty Claim Code (WCC) screen shown above on the job card. Refer to callout 1 above for the location of the WCC on the screen.

3. Record the Warranty Claim Code on the job card for warranty transaction submission.
